Access Compliance Report

Public Rights-of-Way

(Curb Ramps)

Intersection ID: 12419	Main Street: OTTS_ST	Cross Street: SEIGLE_AV	Location:	E
ADA ID: 2F20A826A1F5	Ramp Type: PerpDiag	Initial Pass/Fail: Fail	Overall Compliance: No	Severity Score: 12.5
Codes/Mitigation Info/Possible Solution		Field Measurements/Component Compliance

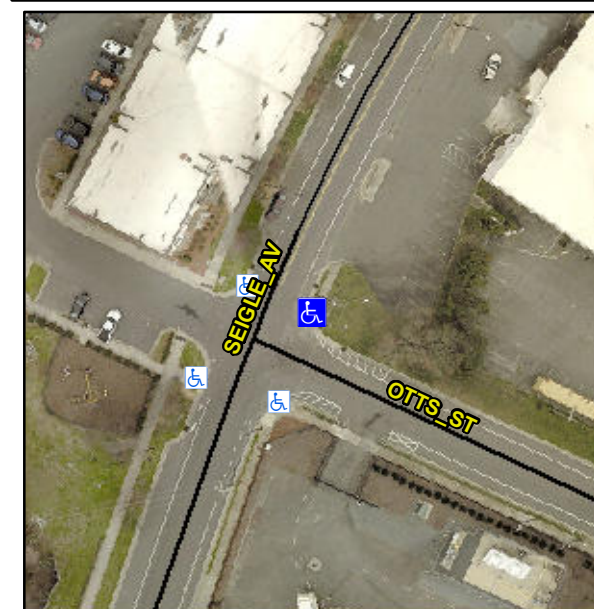
Not Found, R304.2.2

Compliance	Description	Data	Compliance	Description	Data
N/A	Ramp Length (in)	28.0	No	Ramp Slope (%)	11.7
Yes	Ramp Width (in)	60.0	Yes	Ramp XSlope (%)	0.9
N/A	Flare Type LT	N/A	N/A	Flare Type RT	N/A
N/A	Flare Slope LT (%)	N/A	N/A	Flare Slope RT (%)	N/A
N/A	Flare Traversable LT?	N/A	N/A	Flare Traversable RT?	N/A
N/A	Landing Length (in)	N/A	N/A	DWS Provided?	N/A
N/A	Landing Width (in)	N/A	N/A	DWS Contrast?	N/A
N/A	Landing Slope (%)	N/A	N/A	DWS Length (in)	N/A
N/A	Landing X Slope (%)	N/A	N/A	DWS Full Width?	N/A
N/A	Landing Curb? (Y/N)	N/A	N/A	DWS Offset (in)	N/A
N/A	Shared Landing?	N/A			
N/A	Gutter Ponding?	N/A	N/A	Gutter Slope (%)	N/A
N/A	Gutter Lip Ht (in)	2.0	N/A	Gutter X Slope (%)	N/A
N/A	Painted X Walk1?	No	N/A	Painted X Walk2?	No
	X Walk 1 Direction	To NW		X Walk 2 Direction	To SW
N/A	X Walk 1 Width (in)	N/A	N/A	X Walk 2 Width (in)	N/A
	X Walk 1 Slope (%)	7.2		X Walk 2 Slope (%)	2.6
	X Walk 1 X Slope (%)	2.6		X Walk 2 X Slope (%)	1.6

N/A	Ramp inside XWalk1?	N/A	N/A	Ramp inside XWalk2?	N/A
	Road Slope (%)	2.7	N/A	Clear Space?	N/A
	Road X Slope (%)	0.4	N/A	Clear Space to XWalk (in)	N/A
N/A	Any Obstructions?	N/A	N/A	Storm Grate/Utility Hazard?	N/A
	Obstruction Type			Storm Grate/Utility Type	
		N/A			N/A
			Yes	Surface Condition? (G/P)	Good

Possible Solutions:

Remove & Replace Curb Ramp With Two New Directional Ramps or Equivalent.
