# Access Compliance Report

## Public Rights-of-Way

### (Curb Ramps)

Intersection ID: 10032503	Main Street: N_CALDWELL_ST	Cross Street: N/A	Location: E
ADA ID: 2F48C8F17565	Ramp Type: Perp	Initial Pass/Fail: Fail	Overall Compliance: No
Codes/Mitigation Info/Possible Solution		Field Measurements/Component Compliance	
Severity Score: 12.5

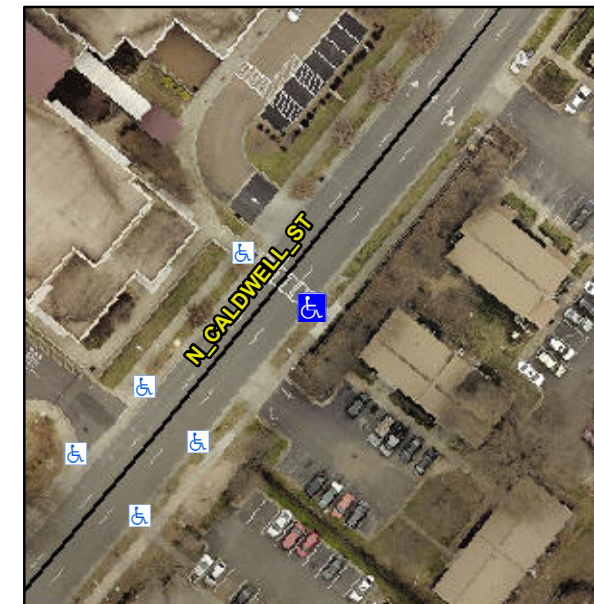
**Not Found, R304.2.2**

Compliance	Description	Data	Compliance	Description	Data
N/A	Ramp Length (in)	86.0	No	Ramp Slope (%)	8.9
Yes	Ramp Width (in)	60.5	Yes	Ramp XSlope (%)	0.7
N/A	Flare Type LT	N/A	N/A	Flare Type RT	N/A
N/A	Flare Slope LT (%)	N/A	N/A	Flare Slope RT (%)	N/A
N/A	Flare Traversable LT?	N/A	N/A	Flare Traversable RT?	N/A
N/A	Landing Length (in)	N/A	N/A	DWS Provided?	N/A
N/A	Landing Width (in)	N/A	N/A	DWS Contrast?	N/A
N/A	Landing Slope (%)	N/A	N/A	DWS Length (in)	N/A
N/A	Landing X Slope (%)	N/A	N/A	DWS Full Width?	N/A
N/A	Landing Curb? (Y/N)	N/A	N/A	DWS Offset (in)	N/A
N/A	Shared Landing?	N/A			
N/A	Gutter Ponding?	N/A	N/A	Gutter Slope (%)	N/A
N/A	Gutter Lip Ht (in)	N/A	N/A	Gutter X Slope (%)	N/A
N/A	Painted X Walk1?	Yes	N/A	Painted X Walk2?	N/A
	X Walk 1 Direction	To NW		X Walk 2 Direction	N/A
N/A	X Walk 1 Width (in)	112.0	N/A	X Walk 2 Width (in)	N/A
	X Walk 1 Slope (%)	3.6		X Walk 2 Slope (%)	N/A
	X Walk 1 X Slope (%)	1.2		X Walk 2 X Slope (%)	N/A

N/A	Ramp inside XWalk1?	Yes	N/A	Ramp inside XWalk2?	N/A
	Road Slope (%)	N/A	N/A	Clear Space?	N/A
	Road X Slope (%)	N/A	N/A	Clear Space to XWalk (in)	N/A
N/A	Any Obstructions?	N/A	N/A	Storm Grate/Utility Hazard?	N/A
	Obstruction Type			Storm Grate/Utility Type	
		N/A			N/A
			Yes	Surface Condition? (G/P)	Good

Possible Solutions:

**Remove & Replace Entire Ramp.**
