# Access Compliance Report

## Public Rights-of-Way

### (Curb Ramps)

Intersection ID: 10199	Main Street: CALTON_LN	Cross Street: TUCKASEEGEE_RD	Location: W
ADA ID: 2F4D1D56C6C2	Ramp Type: Perp	Initial Pass/Fail: Fail	Overall Compliance: No
		Severity Score: 12.5

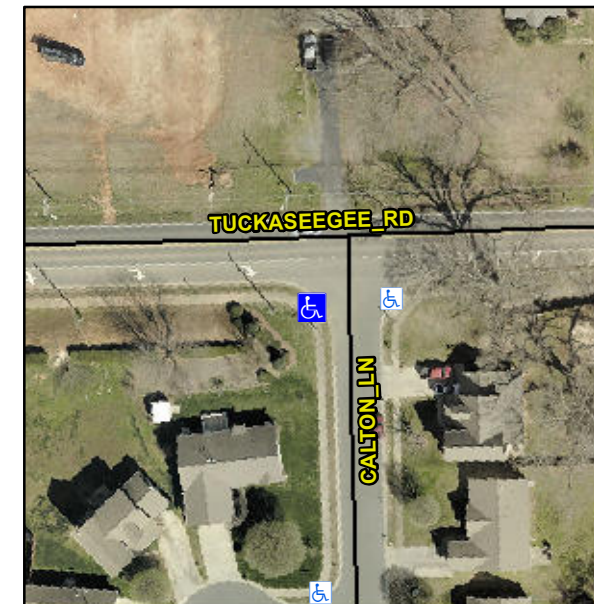
**Not Found, R304.2.2**

Compliance	Description	Data	Compliance	Description	Data
N/A	Ramp Length (in)	50.0	No	Ramp Slope (%)	8.7
Yes	Ramp Width (in)	53.0	Yes	Ramp XSlope (%)	0.0
N/A	Flare Type LT	N/A	N/A	Flare Type RT	N/A
N/A	Flare Slope LT (%)	N/A	N/A	Flare Slope RT (%)	N/A
N/A	Flare Traversable LT?	N/A	N/A	Flare Traversable RT?	N/A
N/A	Landing Length (in)	N/A	N/A	DWS Provided?	N/A
N/A	Landing Width (in)	N/A	N/A	DWS Contrast?	N/A
N/A	Landing Slope (%)	N/A	N/A	DWS Length (in)	N/A
N/A	Landing X Slope (%)	N/A	N/A	DWS Full Width?	N/A
N/A	Landing Curb? (Y/N)	N/A	N/A	DWS Offset (in)	N/A
N/A	Shared Landing?	N/A			
N/A	Gutter Ponding?	N/A	N/A	Gutter Slope (%)	N/A
N/A	Gutter Lip Ht (in)	0.5	N/A	Gutter X Slope (%)	N/A
N/A	Painted X Walk1?	No	N/A	Painted X Walk2?	N/A
	X Walk 1 Direction	To E		X Walk 2 Direction	N/A
N/A	X Walk 1 Width (in)	N/A	N/A	X Walk 2 Width (in)	N/A
	X Walk 1 Slope (%)	0.0		X Walk 2 Slope (%)	N/A
	X Walk 1 X Slope (%)	1.1		X Walk 2 X Slope (%)	N/A

N/A	Ramp inside XWalk1?	N/A	N/A	Ramp inside XWalk2?	N/A
	Road Slope (%)	N/A	N/A	Clear Space?	N/A
	Road X Slope (%)	N/A	N/A	Clear Space to XWalk (in)	N/A
N/A	Any Obstructions?	N/A	N/A	Storm Grate/Utility Hazard?	N/A
	Obstruction Type			Storm Grate/Utility Type	
		N/A			N/A
			Yes	Surface Condition? (G/P)	Good

**Remove & Replace Entire Ramp.**
