# Access Compliance Report

## Public Rights-of-Way

### (Curb Ramps)

| Intersection ID: 45756 | Main Street: CHRISTENBURY_RD | Cross Street: GRANDEUR_RD | Location: | SE |

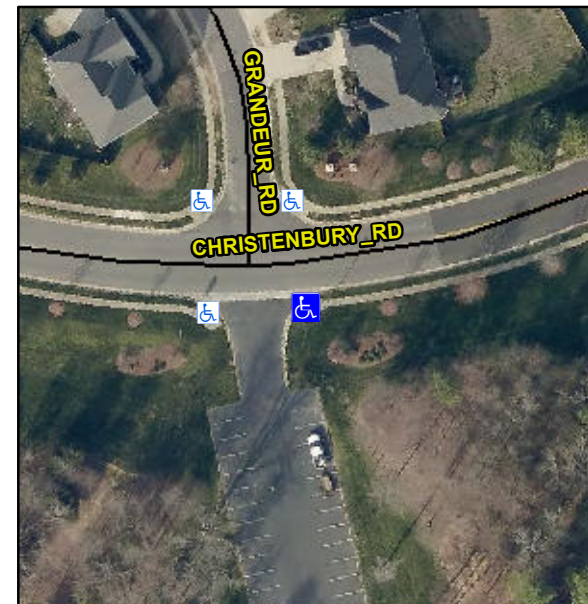
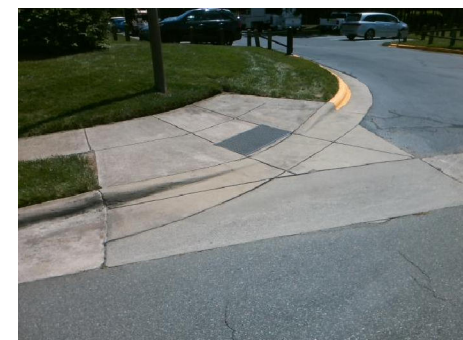
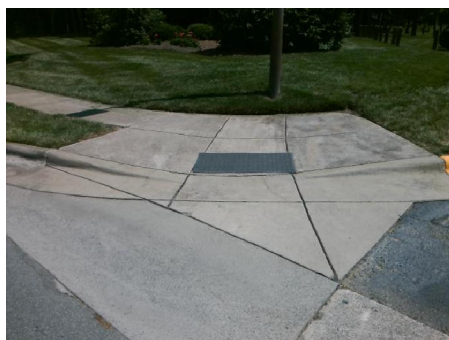
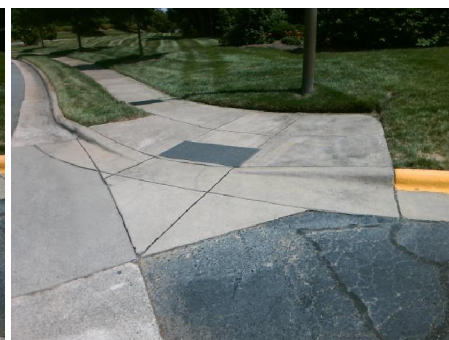
| ADA ID: 2F5092344231 | Ramp Type: PerpDiag | Initial Pass/Fail: Fail | Overall Compliance: No | Severity Score: 10 |

**N/A**

**R304.5.1, R304.5.3**

| Compliance | Description | Data | Compliance | Description | Data |
|---|---|---|---|---|---|
| N/A | Ramp Length (in) | 47.0 | Yes | Ramp Slope (%) | 6.6 |
| No | Ramp Width (in) | 41.0 | No | Ramp XSlope (%) | 2.7 |

**Remove & Replace Curb Ramp With Two New Directional Ramps or Equivalent.**
