Access Compliance Report

Public Rights-of-Way (Curb Ramps)

Intersection ID: 10025795	Main Street: EDGEHILL_RD_NORTH	Cross Street: N/A	Location: NE
ADA ID: 2F61182FFA78	Ramp Type: Directional1	Initial Pass/Fail: Fail	Overall Compliance: No
Severity Score: 46.25			
Codes/Mitigation Info/Possible Solution		Field Measurements/Component Compliance

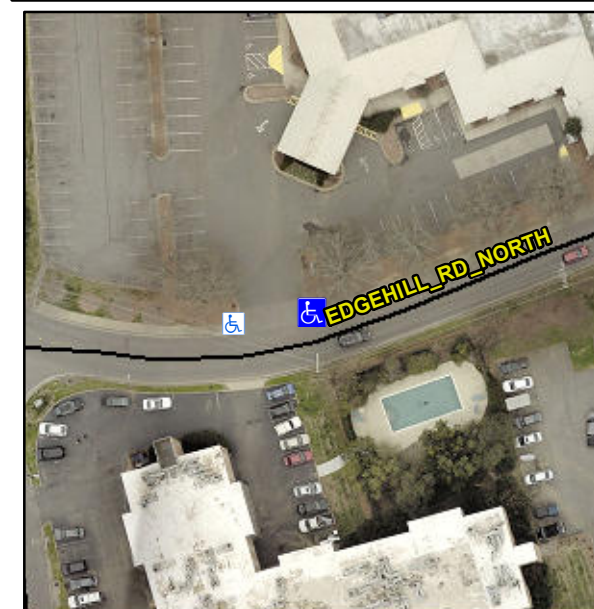
R304.5.1, R304.2.2, R304.5.3

Compliance	Description	Data	Compliance	Description	Data
N/A	Ramp Length (in)	20.0	N/A	Grade Break?	N/A
No	Ramp Width (in)	45.0	N/A	Grade Break Slope (%)	0.0
No	Ramp Slope (%)	18.5	N/A	Grade Break XSlope (%)	0.0
No	Ramp XSlope (%)	5.6			
N/A	Flare Type LT	N/A	N/A	Flare Type RT	N/A
N/A	Flare Slope LT (%)	N/A	N/A	Flare Slope RT (%)	0.0
N/A	Flare Traversable LT?	N/A	N/A	Flare Traversable RT?	N/A
N/A	Landing Length (in)	0.0	N/A	DWS Provided?	N/A
N/A	Landing Width (in)	0.0	N/A	DWS Contrast?	N/A
N/A	Landing Slope (%)	0.0	N/A	DWS Length (in)	N/A
N/A	Landing X Slope (%)	0.0	N/A	DWS Full Width?	N/A
N/A	Landing Curb? (Y/N)	N/A	N/A	DWS Offset LT (in)	N/A
N/A	Shared Landing?	N/A	N/A	DWS Offset RT (in)	N/A
N/A	Gutter Ponding?	0.0	N/A	Gutter Slope (%)	N/A
N/A	Gutter Lip Ht (in)	0.0	N/A	Gutter X Slope (%)	N/A
N/A	Painted X Walk1?	No		Road Slope (%)	3.6
	X Walk 1 Direction	To SW		Road X Slope (%)	3.5
	X Walk 1 Width (in)	N/A		Clear Space?	N/A

X Walk 1 Slope (%)	3.6	N/A	Clear Space to XWalk (in)	N/A
	X Walk 1 X Slope (%)	3.5	N/A	Storm Grate/Utility Hazard?	N/A
N/A	Ramp inside XWalk1?	N/A		Storm Grate/Utility Type	
N/A	Any Obstructions?	N/A			N/A
	Obstruction Type		Yes	Surface Condition? (G/P)	Good
			N/A	Curb Slope (%)	7.0

Possible Solutions:

Remove & Replace Entire Ramp.
