Access Compliance Report

Public Rights-of-Way

(Curb Ramps)

Intersection ID: 50636	Main Street: BLUE_GROVE_RD	Cross Street: RED_WATER_RD	Location: NW
ADA ID: 2F7C3566B1C6	Ramp Type: Perp	Initial Pass/Fail: Fail	Overall Compliance: No
			Severity Score: 13.75

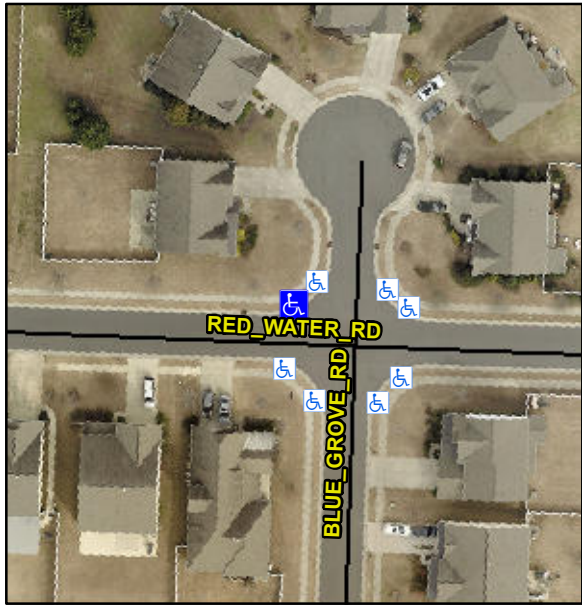
Possible Solutions:		Compliance	Description	Data	Compliance	Description	Data
	Remove & Replace Entire Ramp.		N/A	Ramp Length (in)	44.0	No	Ramp Slope (%)	9.1
			Yes	Ramp Width (in)	48.0	No	Ramp XSlope (%)	3.0
			N/A	Flare Type LT	N/A	N/A	Flare Type RT	N/A
			N/A	Flare Slope LT (%)	N/A	N/A	Flare Slope RT (%)	N/A
			N/A	Flare Traversable LT?	N/A	N/A	Flare Traversable RT?	N/A
			N/A	Landing Length (in)	N/A	N/A	DWS Provided?	N/A
			N/A	Landing Width (in)	N/A	N/A	DWS Contrast?	N/A
			N/A	Landing Slope (%)	N/A	N/A	DWS Length (in)	N/A
			N/A	Landing X Slope (%)	N/A	N/A	DWS Full Width?	N/A
Surveyor Notes:		N/A	N/A	Landing Curb? (Y/N)	N/A	N/A	DWS Offset (in)	N/A
PROW/ADA:		Not Found, R304.2.2, R304.5.3	N/A	Shared Landing?	N/A			
			N/A	Gutter Ponding?	N/A	N/A	Gutter Slope (%)	N/A
			N/A	Gutter Lip Ht (in)	N/A	N/A	Gutter X Slope (%)	N/A
