Access Compliance Report

Public Rights-of-Way

(Curb Ramps)

Intersection ID: 25988	Main Street: BLUE_HERON_DR	Cross Street: NIGHTINGALE_LN	Location: NW
ADA ID: 2F8F29781758	Ramp Type: Directional1	Initial Pass/Fail: Fail	Overall Compliance: No
		Severity Score: 12.5

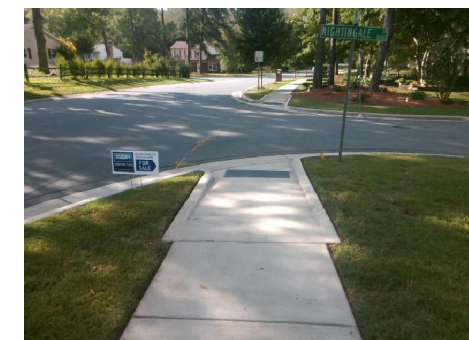
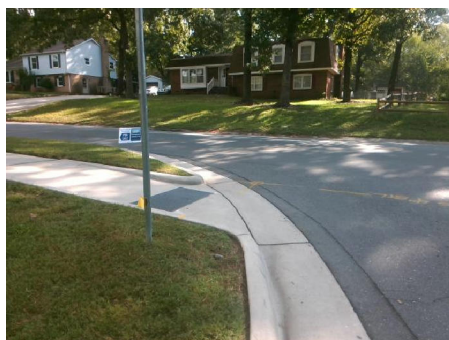
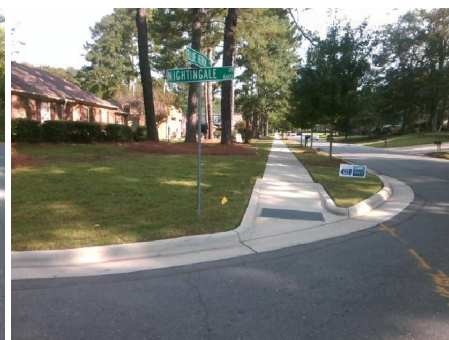
Compliance	Description	Data	Compliance	Description	Data
N/A	Ramp Length (in)	138.0	N/A	Grade Break?	N/A
Yes	Ramp Width (in)	58.0	N/A	Grade Break Slope (%)	0.0
No	Ramp Slope (%)	10.8	N/A	Grade Break XSlope (%)	0.0
Yes	Ramp XSlope (%)	1.0			
N/A	Flare Type LT	N/A	N/A	Flare Type RT	N/A
N/A	Flare Slope LT (%)	N/A	N/A	Flare Slope RT (%)	0.0
N/A	Flare Traversable LT?	N/A	N/A	Flare Traversable RT?	N/A
N/A	Landing Length (in)	0.0	N/A	DWS Provided?	N/A
N/A	Landing Width (in)	0.0	N/A	DWS Contrast?	N/A
N/A	Landing Slope (%)	0.0	N/A	DWS Length (in)	N/A
N/A	Landing X Slope (%)	0.0	N/A	DWS Full Width?	N/A
N/A	Landing Curb? (Y/N)	N/A	N/A	DWS Offset LT (in)	N/A
N/A	Shared Landing?	N/A	N/A	DWS Offset RT (in)	N/A
N/A	Gutter Ponding?	0.0	N/A	Gutter Slope (%)	N/A
N/A	Gutter Lip Ht (in)	0.0	N/A	Gutter X Slope (%)	N/A
N/A	Painted X Walk1?	No		Road Slope (%)	1.6
	X Walk 1 Direction	To S		Road X Slope (%)	6.5
	X Walk 1 Width (in)	N/A		Clear Space?	N/A

X Walk 1 Slope (%)	1.6	N/A	Clear Space to XWalk (in)	N/A
	X Walk 1 X Slope (%)	6.5	N/A	Storm Grate/Utility Hazard?	N/A
N/A	Ramp inside XWalk1?	N/A		Storm Grate/Utility Type	
N/A	Any Obstructions?	N/A			N/A
	Obstruction Type		Yes	Surface Condition? (G/P)	Good
			N/A	Curb Slope (%)	1.9

Remove & Replace Entire Ramp.
