# Access Compliance Report

## Public Rights-of-Way

### (Curb Ramps)

Intersection ID: 24499	Main Street: BECKMORE_PL	Cross Street: SAINTFIELD_PL	Location: SE
ADA ID: 2FA3B118CC3B	Ramp Type: Perp	Initial Pass/Fail: Fail	Overall Compliance: No
Severity Score: 25			
Codes/Mitigation Info/Possible Solution		Field Measurements/Component Compliance

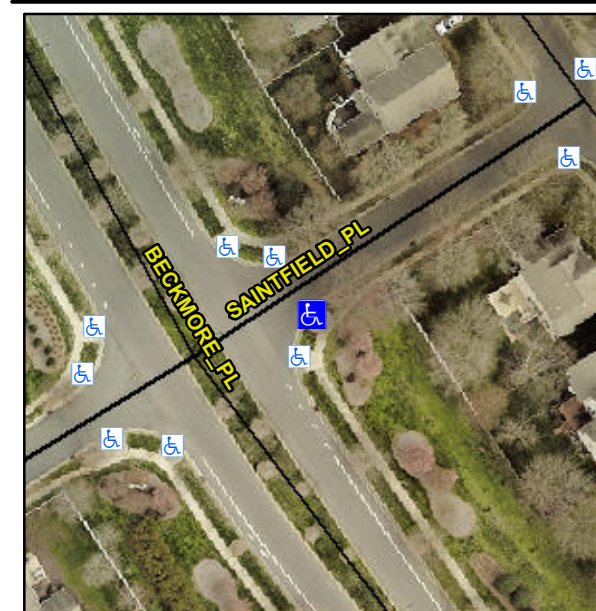
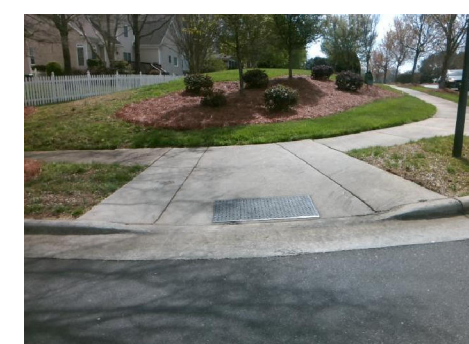
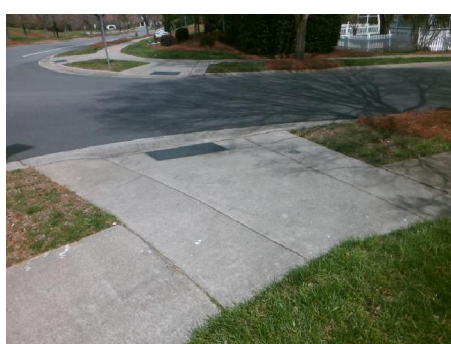
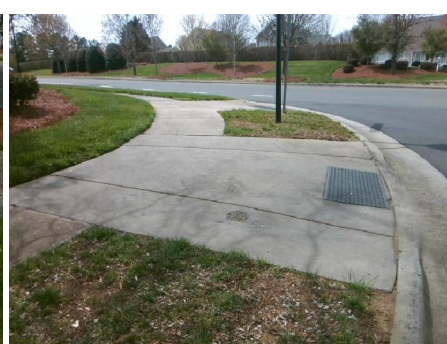
**Not Found, R304.2.2, R304.5.3**

Compliance	Description	Data	Compliance	Description	Data
N/A	Ramp Length (in)	93.0	No	Ramp Slope (%)	8.7
Yes	Ramp Width (in)	75.0	No	Ramp XSlope (%)	6.4
N/A	Flare Type LT	N/A	N/A	Flare Type RT	N/A
N/A	Flare Slope LT (%)	N/A	N/A	Flare Slope RT (%)	N/A
N/A	Flare Traversable LT?	N/A	N/A	Flare Traversable RT?	N/A
N/A	Landing Length (in)	N/A	N/A	DWS Provided?	N/A
N/A	Landing Width (in)	N/A	N/A	DWS Contrast?	N/A
N/A	Landing Slope (%)	N/A	N/A	DWS Length (in)	N/A
N/A	Landing X Slope (%)	N/A	N/A	DWS Full Width?	N/A
N/A	Landing Curb? (Y/N)	N/A	N/A	DWS Offset (in)	N/A
N/A	Shared Landing?	N/A			
N/A	Gutter Ponding?	N/A	N/A	Gutter Slope (%)	N/A
N/A	Gutter Lip Ht (in)	N/A	N/A	Gutter X Slope (%)	N/A
N/A	Painted X Walk1?	No	N/A	Painted X Walk2?	N/A
	X Walk 1 Direction	To N		X Walk 2 Direction	N/A
N/A	X Walk 1 Width (in)	N/A	N/A	X Walk 2 Width (in)	N/A
	X Walk 1 Slope (%)	0.9		X Walk 2 Slope (%)	N/A
	X Walk 1 X Slope (%)	4.7		X Walk 2 X Slope (%)	N/A

N/A	Ramp inside XWalk1?	N/A	N/A	Ramp inside XWalk2?	N/A
	Road Slope (%)	N/A	N/A	Clear Space?	N/A
	Road X Slope (%)	N/A	N/A	Clear Space to XWalk (in)	N/A
N/A	Any Obstructions?	N/A	N/A	Storm Grate/Utility Hazard?	N/A
	Obstruction Type			Storm Grate/Utility Type	
		N/A			N/A
			Yes	Surface Condition? (G/P)	Good

**Remove & Replace Entire Ramp.**

Total Cost: \$ 1850.00
