# Access Compliance Report

## Public Rights-of-Way

### (Curb Ramps)

| Intersection ID: 14547 | Main Street: EAST_BV | Cross Street: SPRINGDALE_AV | Location: W |

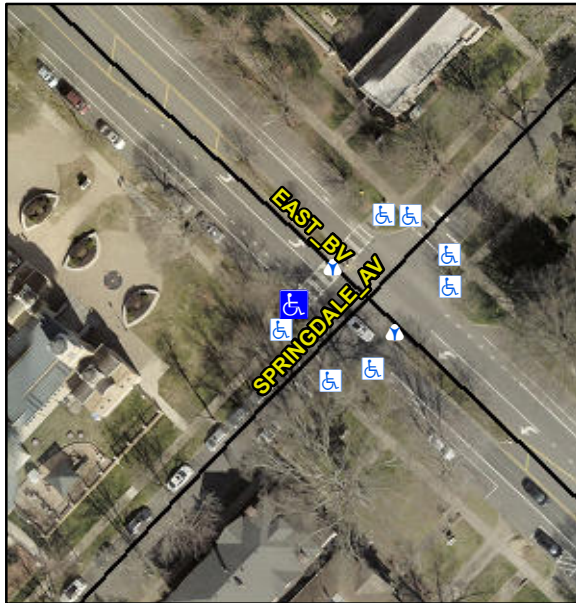
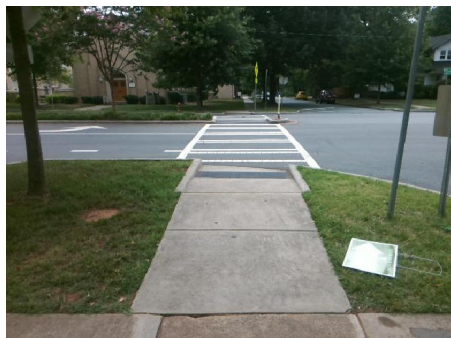
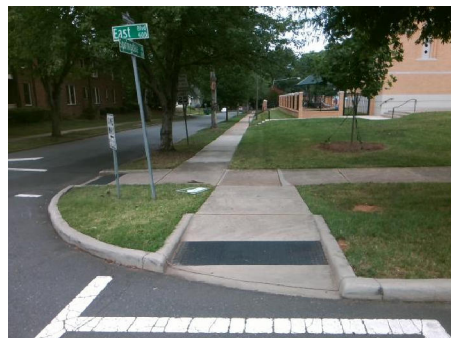
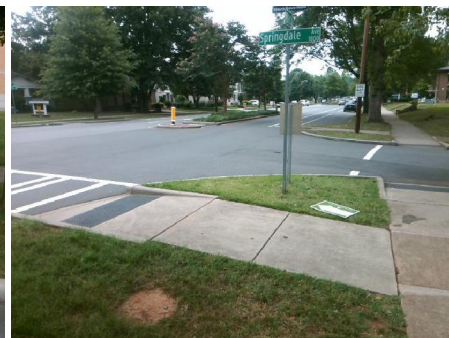
**LNDG SLOPE NEGATIVE**

**R304.5.3, R304.2.2-Perp, R304.3.2-Para**

| Compliance | Description | Data | Compliance | Description | Data |
|---|---|---|---|---|---|
| No | Ramp XSlope (%) | 3.1 | | | |
| No | Landing Slope (%) | 9.7 | Yes | DWS Length (in) | 25.0 |
| Yes | Gutter Lip Ht (in) | 0.0 | No | Gutter X Slope (%) | 2.5 |

**Remove & Replace Entire Ramp.  
Remove & Replace Gutter.**

Total Cost: \$ 2350.00
