Access Compliance Report

Public Rights-of-Way

(Curb Ramps)

Intersection ID: 2596	Main Street: FAIRVISTA_DR	Cross Street: KNIGHTSGATE_CT	Location: SW
ADA ID: 2FC676BACBF6	Ramp Type: PerpDiag	Initial Pass/Fail: Fail	Overall Compliance: No
Severity Score: 25			
Codes/Mitigation Info/Possible Solution		Field Measurements/Component Compliance

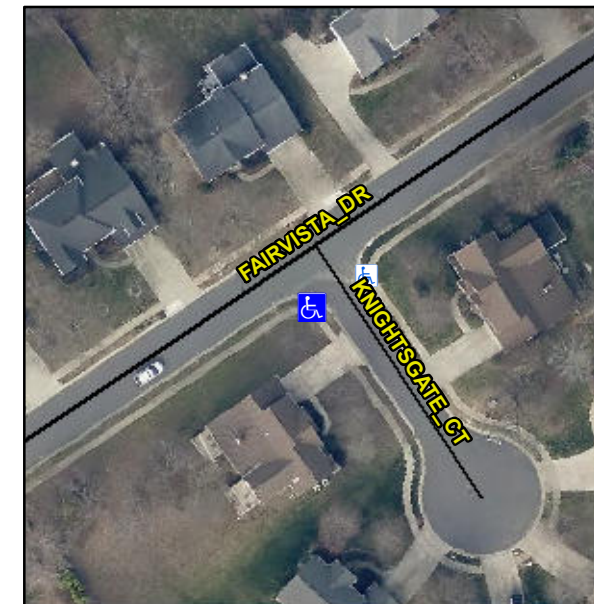
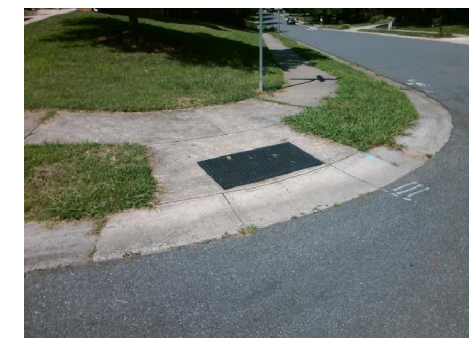
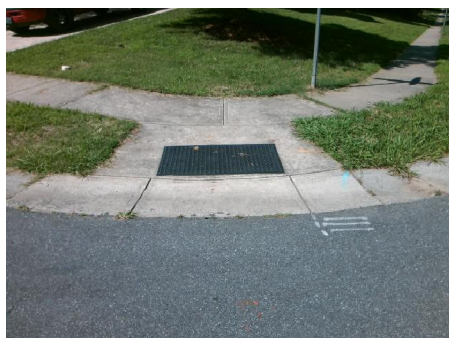
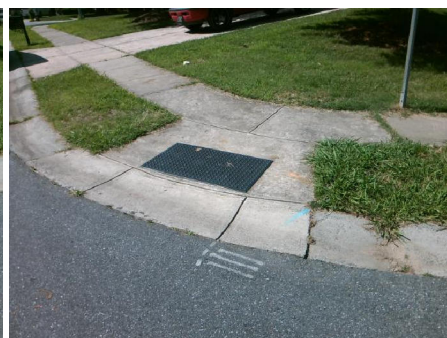
Not Found, R304.2.2, R304.5.3

Compliance	Description	Data	Compliance	Description	Data
N/A	Ramp Length (in)	47.0	No	Ramp Slope (%)	9.3
Yes	Ramp Width (in)	48.0	No	Ramp XSlope (%)	5.1
N/A	Flare Type LT	N/A	N/A	Flare Type RT	N/A
N/A	Flare Slope LT (%)	N/A	N/A	Flare Slope RT (%)	N/A
N/A	Flare Traversable LT?	N/A	N/A	Flare Traversable RT?	N/A
N/A	Landing Length (in)	N/A	N/A	DWS Provided?	N/A
N/A	Landing Width (in)	N/A	N/A	DWS Contrast?	N/A
N/A	Landing Slope (%)	N/A	N/A	DWS Length (in)	N/A
N/A	Landing X Slope (%)	N/A	N/A	DWS Full Width?	N/A
N/A	Landing Curb? (Y/N)	N/A	N/A	DWS Offset (in)	N/A
N/A	Shared Landing?	N/A			
N/A	Gutter Ponding?	N/A	N/A	Gutter Slope (%)	N/A
N/A	Gutter Lip Ht (in)	N/A	N/A	Gutter X Slope (%)	N/A
N/A	Painted X Walk1?	No	N/A	Painted X Walk2?	No
	X Walk 1 Direction	To E		X Walk 2 Direction	To NW
N/A	X Walk 1 Width (in)	N/A	N/A	X Walk 2 Width (in)	N/A
	X Walk 1 Slope (%)	5.4		X Walk 2 Slope (%)	3.3
	X Walk 1 X Slope (%)	3.7		X Walk 2 X Slope (%)	5.0

N/A	Ramp inside XWalk1?	N/A	N/A	Ramp inside XWalk2?	N/A
	Road Slope (%)	6.5	N/A	Clear Space?	N/A
	Road X Slope (%)	2.4	N/A	Clear Space to XWalk (in)	N/A
N/A	Any Obstructions?	N/A	N/A	Storm Grate/Utility Hazard?	N/A
	Obstruction Type			Storm Grate/Utility Type	
		N/A			N/A
			Yes	Surface Condition? (G/P)	Good

Remove & Replace Curb Ramp With Two New Directional Ramps or Equivalent.

Total Cost: \$ 3200.00
