Access Compliance Report

Public Rights-of-Way

(Curb Ramps)

Intersection ID: 31296	Main Street: DEERTON_RD	Cross Street: MELSTRAND_WY	Location: S
ADA ID: 2FD018C2F68E	Ramp Type: PerpDiag	Initial Pass/Fail: Fail	Overall Compliance: No
Severity Score: 58.75			
Codes/Mitigation Info/Possible Solution		Field Measurements/Component Compliance

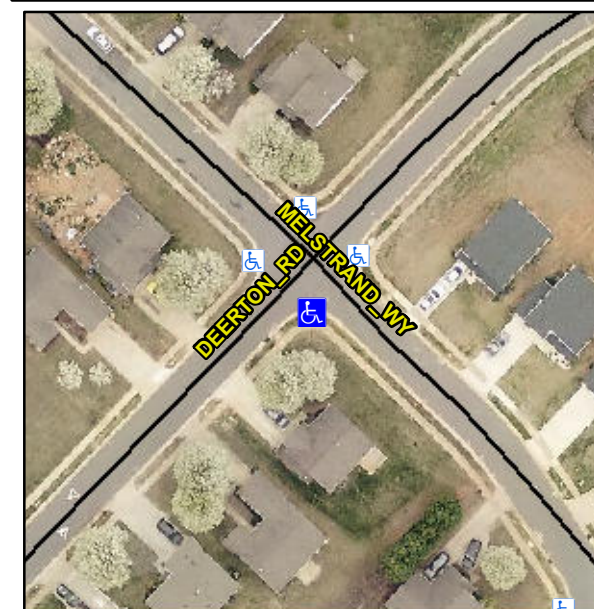
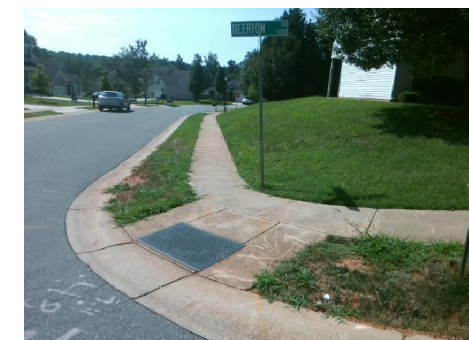
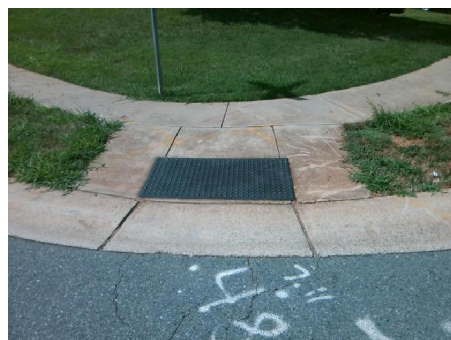
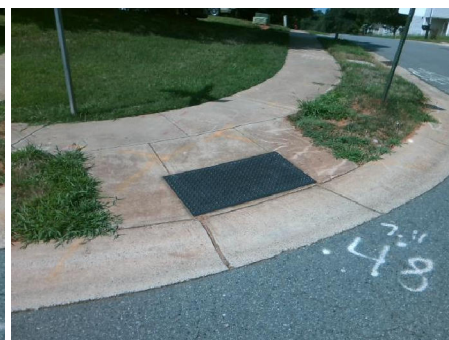
Compliance	Description	Data	Compliance	Description	Data
N/A	Ramp Length (in)	55.0	No	Ramp Slope (%)	12.4
No	Ramp Width (in)	39.0	No	Ramp XSlope (%)	9.4
N/A	Flare Type LT	N/A	N/A	Flare Type RT	N/A
N/A	Flare Slope LT (%)	N/A	N/A	Flare Slope RT (%)	N/A
N/A	Flare Traversable LT?	N/A	N/A	Flare Traversable RT?	N/A
N/A	Landing Length (in)	N/A	N/A	DWS Provided?	N/A
N/A	Landing Width (in)	N/A	N/A	DWS Contrast?	N/A
N/A	Landing Slope (%)	N/A	N/A	DWS Length (in)	N/A
N/A	Landing X Slope (%)	N/A	N/A	DWS Full Width?	N/A
N/A	Landing Curb? (Y/N)	N/A	N/A	DWS Offset (in)	N/A
N/A	Shared Landing?	N/A			
N/A	Gutter Ponding?	N/A	N/A	Gutter Slope (%)	N/A
N/A	Gutter Lip Ht (in)	N/A	N/A	Gutter X Slope (%)	N/A
N/A	Painted X Walk1?	No	N/A	Painted X Walk2?	No
	X Walk 1 Direction	To NE		X Walk 2 Direction	To NW
N/A	X Walk 1 Width (in)	N/A	N/A	X Walk 2 Width (in)	N/A
	X Walk 1 Slope (%)	3.1		X Walk 2 Slope (%)	7.4
	X Walk 1 X Slope (%)	7.6		X Walk 2 X Slope (%)	5.5

N/A	Ramp inside XWalk1?	N/A	N/A	Ramp inside XWalk2?	N/A
	Road Slope (%)	8.6	N/A	Clear Space?	N/A
	Road X Slope (%)	0.4	N/A	Clear Space to XWalk (in)	N/A
N/A	Any Obstructions?	N/A	N/A	Storm Grate/Utility Hazard?	N/A
	Obstruction Type			Storm Grate/Utility Type	
		N/A			N/A
		Yes		Surface Condition? (G/P)	Good

Possible Solutions:

Remove & Replace Curb Ramp With Two New Directional Ramps or Equivalent.

R304.5.1, R304.2.2, R304.5.3
