Access Compliance Report

Public Rights-of-Way

(Curb Ramps)

Intersection ID: 12516	Main Street: ARTY_AV	Cross Street: W_MOREHEAD_ST	Location: S
ADA ID: 2FD6C56443E0	Ramp Type: Perp	Initial Pass/Fail: Fail	Overall Compliance: No
Severity Score: 10			
Codes/Mitigation Info/Possible Solution		Field Measurements/Component Compliance

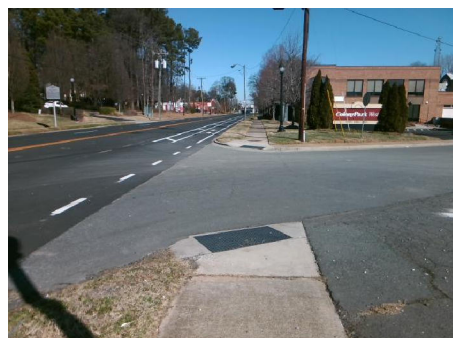
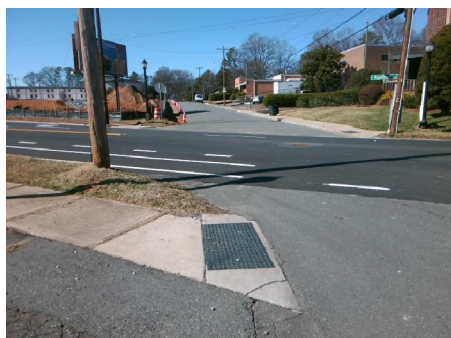
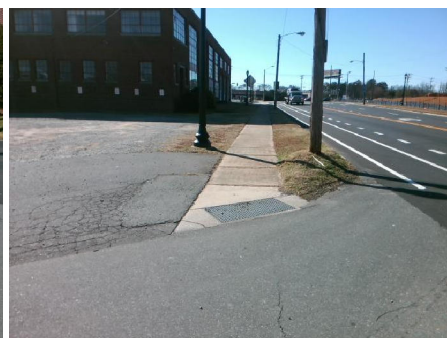
Compliance	Description	Data	Compliance	Description	Data
N/A	Ramp Length (in)	55.5	Yes	Ramp Slope (%)	5.0
No	Ramp Width (in)	47.5	No	Ramp XSlope (%)	2.9
N/A	Flare Type LT	N/A	N/A	Flare Type RT	N/A
N/A	Flare Slope LT (%)	N/A	N/A	Flare Slope RT (%)	N/A
N/A	Flare Traversable LT?	N/A	N/A	Flare Traversable RT?	N/A
N/A	Landing Length (in)	N/A	N/A	DWS Provided?	N/A
N/A	Landing Width (in)	N/A	N/A	DWS Contrast?	N/A
N/A	Landing Slope (%)	N/A	N/A	DWS Length (in)	N/A
N/A	Landing X Slope (%)	N/A	N/A	DWS Full Width?	N/A
N/A	Landing Curb? (Y/N)	N/A	N/A	DWS Offset (in)	N/A
N/A	Shared Landing?	N/A			
N/A	Gutter Ponding?	N/A	N/A	Gutter Slope (%)	N/A
N/A	Gutter Lip Ht (in)	N/A	N/A	Gutter X Slope (%)	N/A
N/A	Painted X Walk1?	No	N/A	Painted X Walk2?	N/A
	X Walk 1 Direction	To NE		X Walk 2 Direction	N/A
N/A	X Walk 1 Width (in)	N/A	N/A	X Walk 2 Width (in)	N/A
	X Walk 1 Slope (%)	1.4		X Walk 2 Slope (%)	N/A
	X Walk 1 X Slope (%)	4.0		X Walk 2 X Slope (%)	N/A

N/A	Ramp inside XWalk1?	N/A	N/A	Ramp inside XWalk2?	N/A
	Road Slope (%)	N/A	N/A	Clear Space?	N/A
	Road X Slope (%)	N/A	N/A	Clear Space to XWalk (in)	N/A
N/A	Any Obstructions?	N/A	N/A	Storm Grate/Utility Hazard?	N/A
	Obstruction Type			Storm Grate/Utility Type	
		N/A			N/A
			Yes	Surface Condition? (G/P)	Good

Possible Solutions:

Remove & Replace Entire Ramp.

R304.5.1, R304.5.3
