# Access Compliance Report

## Public Rights-of-Way (Curb Ramps)

| Intersection ID: 11246 | Main Street: ALLEN_ST | Cross Street: CATAWBA_AV | Location: NW |
| ADA ID: 2FD83E4EE95C | Ramp Type: PerpDiag | Initial Pass/Fail: Fail | Overall Compliance: No |

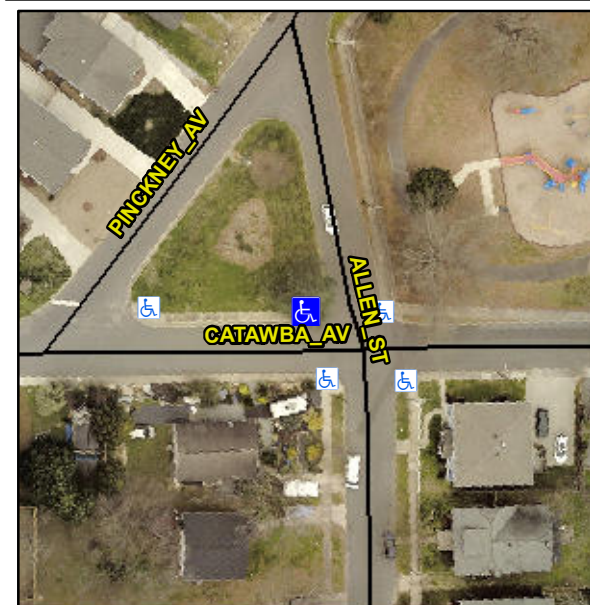
**Not Found, R304.5.3**

| Compliance | Description | Data | Compliance | Description | Data |
|---|---|---|---|---|---|
| N/A | Ramp Length (in) | 25.0 | Yes | Ramp Slope (%) | 6.0 |
| Yes | Ramp Width (in) | 48.0 | No | Ramp XSlope (%) | 9.1 |

**Remove & Replace Curb Ramp With Two New Directional Ramps or Equivalent.**
