Access Compliance Report

Public Rights-of-Way

(Curb Ramps)

Intersection ID: N/A	Main Street: OLMSTED_PARK_PL	Cross Street: WINTHROP_AV	Location: NE
ADA ID: 2FEBF5C4471E	Ramp Type: PerpDiag	Initial Pass/Fail: Fail	Overall Compliance: No
Severity Score: 22.5			
Codes/Mitigation Info/Possible Solution		Field Measurements/Component Compliance

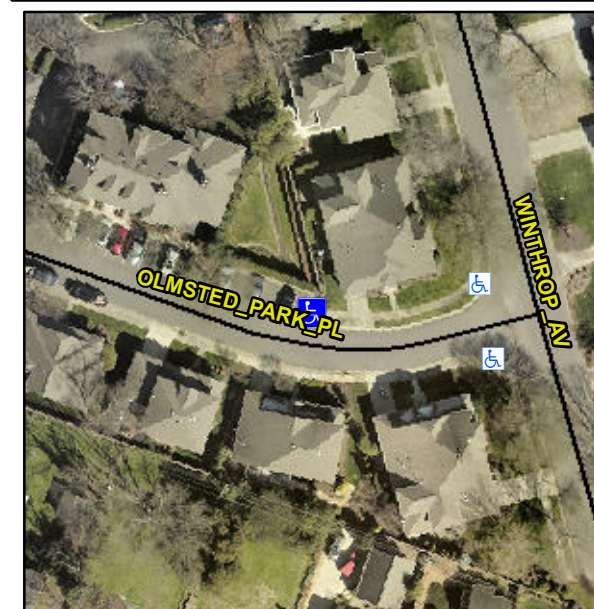
Compliance	Description	Data	Compliance	Description	Data
N/A	Ramp Length (in)	44.0	No	Ramp Slope (%)	9.0
No	Ramp Width (in)	38.0	No	Ramp XSlope (%)	3.7
N/A	Flare Type LT	N/A	N/A	Flare Type RT	N/A
N/A	Flare Slope LT (%)	N/A	N/A	Flare Slope RT (%)	N/A
N/A	Flare Traversable LT?	N/A	N/A	Flare Traversable RT?	N/A
N/A	Landing Length (in)	N/A	N/A	DWS Provided?	N/A
N/A	Landing Width (in)	N/A	N/A	DWS Contrast?	N/A
N/A	Landing Slope (%)	N/A	N/A	DWS Length (in)	N/A
N/A	Landing X Slope (%)	N/A	N/A	DWS Full Width?	N/A
N/A	Landing Curb? (Y/N)	N/A	N/A	DWS Offset (in)	N/A
N/A	Shared Landing?	N/A			
N/A	Gutter Ponding?	N/A	N/A	Gutter Slope (%)	N/A
N/A	Gutter Lip Ht (in)	N/A	N/A	Gutter X Slope (%)	N/A
N/A	Painted X Walk1?	No	N/A	Painted X Walk2?	No
	X Walk 1 Direction	To W		X Walk 2 Direction	To S
N/A	X Walk 1 Width (in)	N/A	N/A	X Walk 2 Width (in)	N/A
	X Walk 1 Slope (%)	3.2		X Walk 2 Slope (%)	6.4
	X Walk 1 X Slope (%)	0.3		X Walk 2 X Slope (%)	5.9

N/A	Ramp inside XWalk1?	N/A	N/A	Ramp inside XWalk2?	N/A
	Road Slope (%)	1.4	N/A	Clear Space?	N/A
	Road X Slope (%)	6.7	N/A	Clear Space to XWalk (in)	N/A
N/A	Any Obstructions?	N/A	N/A	Storm Grate/Utility Hazard?	N/A
	Obstruction Type			Storm Grate/Utility Type	
		N/A			N/A
			Yes	Surface Condition? (G/P)	Good

Possible Solutions:

Remove & Replace Curb Ramp With Two New Directional Ramps or Equivalent.

R304.5.1, R304.2.2, R304.5.3
