Access Compliance Report

Public Rights-of-Way

(Curb Ramps)

Intersection ID: 48454	Main Street: RED_RUST_LN	Cross Street: GOLF_LINKS_DR	Location: NE
ADA ID: 2FF303FE9A29	Ramp Type: Perp	Initial Pass/Fail: Pass	Overall Compliance: No
		Severity Score: 5

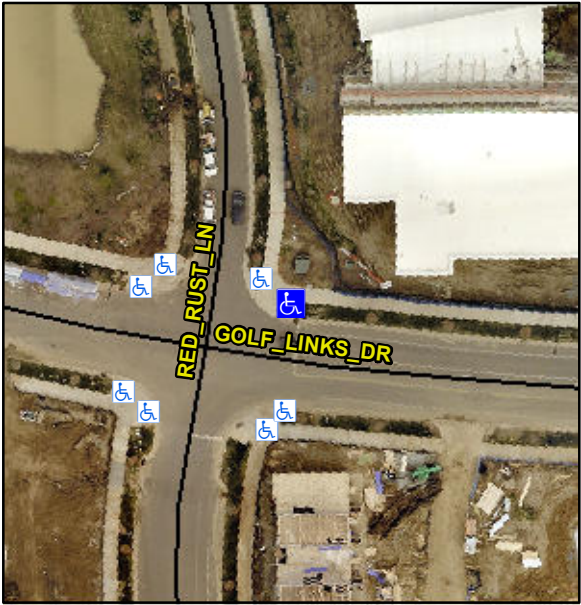
Possible Solutions:		Compliance	Description	Data
	Remove & Replace Entire Ramp.		N/A	Ramp Length (in)	95.0
	Remove & Replace Gutter.		Yes	Ramp Width (in)	61.5
			N/A	Flare Type LT	Sloped
			N/A	Flare Slope LT (%)	6.0
			N/A	Flare Traversable LT?	Yes
			Yes	Landing Length (in)	95.0
			Yes	Landing Width (in)	61.5
			Yes	Landing Slope (%)	0.0
			Yes	Landing X Slope (%)	1.2
<p>Surveyor Notes:</p> <p>N/A</p> <p>PROW/ADA:</p> <p>Not Found, R304.5.4, R304.5.3</p>			N/A	Flare Type RT	N/A
			Yes	Flare Slope RT (%)	7.0
			N/A	Flare Traversable RT?	Yes
			Yes	DWS Provided?	Yes
			Yes	DWS Contrast?	Yes
			Yes	DWS Length (in)	24.0
			Yes	DWS Full Width?	Yes
			N/A	DWS Offset (in)	1.5
			N/A	Shared Landing?	No
			Yes	Gutter Ponding?	No
<p>Total Cost:</p> <p>\$ 2600.00</p>			No	Gutter Slope (%)	7.0
			No	Gutter X Slope (%)	2.2
			N/A	Painted X Walk2?	N/A

X Walk 2 Direction	N/A
			N/A	X Walk 2 Width (in)	N/A
				X Walk 2 Slope (%)	N/A
				X Walk 2 X Slope (%)	N/A
			N/A	Ramp inside XWalk2?	N/A
			N/A	Clear Space?	Yes
			N/A	Clear Space to XWalk (in)	N/A
<p>Yes</p> <p>Obstruction Type</p>			No	Storm Grate/Utility Hazard?	No
				Storm Grate/Utility Type	
			N/A		N/A
			Yes	Surface Condition? (G/P)	Good
