Access Compliance Report

Public Rights-of-Way

(Curb Ramps)

Intersection ID: 43761	Main Street: DERVISH_LN	Cross Street: BIRCHCROFT_LN	Location: SW
ADA ID: 2FF5A38BC2F3	Ramp Type: BlendTrans1	Initial Pass/Fail: Fail	Overall Compliance: No
Severity Score: 18.75			
Codes/Mitigation Info/Possible Solution		Field Measurements/Component Compliance

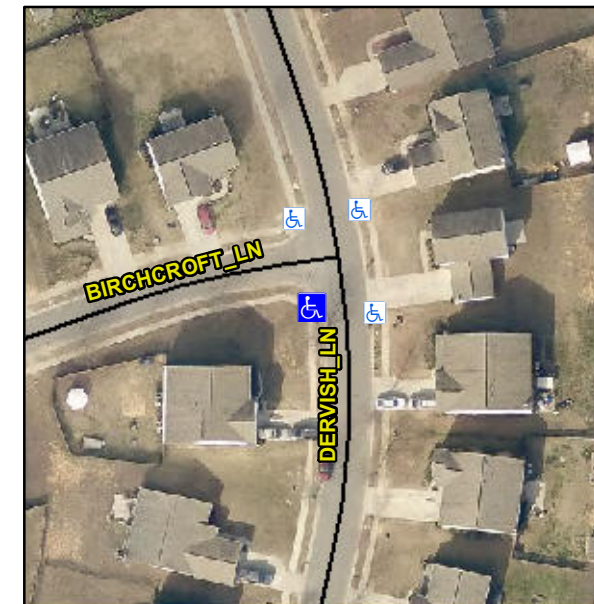
Not Found, R304.5.1, R304.5.3

Compliance	Description	Data	Compliance	Description	Data
N/A	Ramp Length (in)	49.0	Yes	BlendTrans Slope (%)	1.7
No	Ramp Width (in)	35.0	No	BlendTrans XSlope (%)	2.9
N/A	Flare Type LT	N/A	N/A	Flare Type RT	N/A
N/A	Flare Slope LT (%)	N/A	N/A	Flare Slope RT (%)	N/A
N/A	Flare Traversable LT?	N/A	N/A	Flare Traversable RT?	N/A
N/A	Landing Length (in)	N/A	N/A	DWS Provided?	N/A
N/A	Landing Width (in)	N/A	N/A	DWS Contrast?	N/A
N/A	Landing Slope (%)	N/A	N/A	DWS Length (in)	N/A
N/A	Landing X Slope (%)	N/A	N/A	DWS Full Width?	N/A
N/A	Landing Curb? (Y/N)	N/A	N/A	DWS Offset (in)	N/A
N/A	Shared Landing?	N/A			
N/A	Gutter Ponding?	N/A	N/A	Gutter Slope (%)	N/A
N/A	Gutter Lip Ht (in)	N/A	N/A	Gutter X Slope (%)	N/A
N/A	Painted X Walk1?	No	N/A	Painted X Walk2?	No
	X Walk 1 Direction	To E		X Walk 2 Direction	To N
	X Walk 1 Width (in)	N/A		X Walk 2 Width (in)	N/A
	X Walk 1 Slope (%)	3.4		X Walk 2 Slope (%)	1.1
	X Walk 1 X Slope (%)	1.4		X Walk 2 X Slope (%)	0.9

N/A	Ramp inside XWalk1?	N/A	N/A	Ramp inside XWalk2?	N/A
	Road Slope (%)	2.1		Clear Space?	N/A
	Road X Slope (%)	5.8	N/A	Clear Space to XWalk (in)	N/A
N/A	Any Obstructions?	N/A	N/A	Storm Grate/Utility Hazard?	N/A
	Obstruction Type			Storm Grate/Utility Type	
		N/A			N/A
			Yes	Surface Condition? (G/P)	Good
			No	Curb Slope (%)	12.3

Remove & Replace Curb Ramp With Two New Directional Ramps or Equivalent.

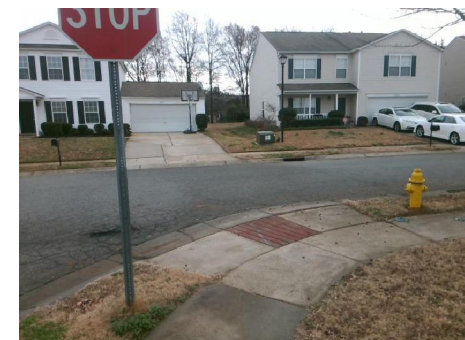
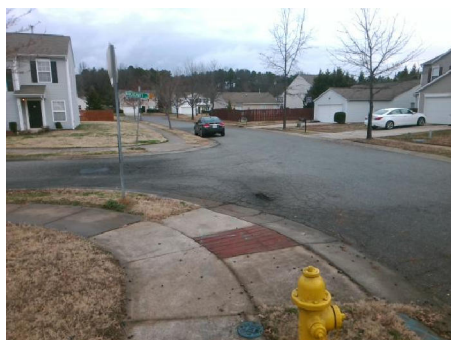
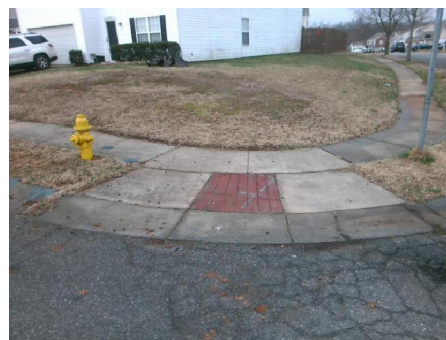
Street 1 Name DERVISH LN

Stop Condition-Street 1 None

Street 2 Name BIRCHCROFT LN

Stop Condition-Street 2 StopSign
