# Access Compliance Report

## Public Rights-of-Way

### (Curb Ramps)

Intersection ID: 10018967	Main Street: BRAWER_FARM_DR	Cross Street: N/A	Location: NE
ADA ID: 3012B4F27B89	Ramp Type: Perp	Initial Pass/Fail: Fail	Overall Compliance: No
Codes/Mitigation Info/Possible Solution		Field Measurements/Component Compliance

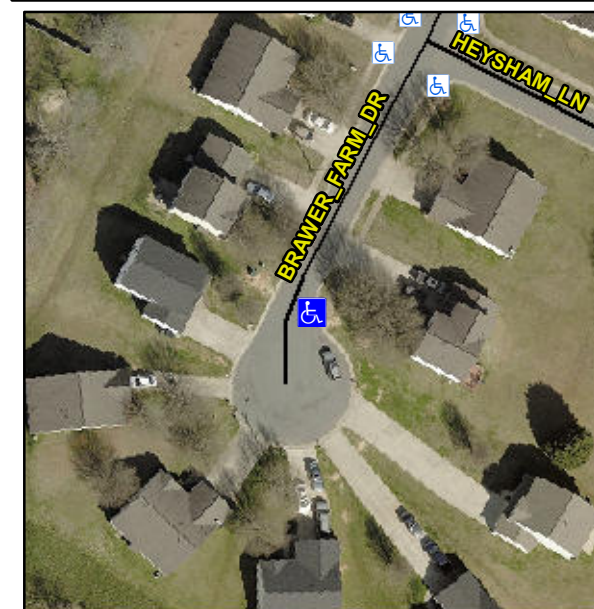
**Not Found, R304.5.1, R304.5.3**

Compliance	Description	Data	Compliance	Description	Data
N/A	Ramp Length (in)	46.5	Yes	Ramp Slope (%)	7.3
No	Ramp Width (in)	41.0	No	Ramp XSlope (%)	4.2
N/A	Flare Type LT	N/A	N/A	Flare Type RT	N/A
N/A	Flare Slope LT (%)	N/A	N/A	Flare Slope RT (%)	N/A
N/A	Flare Traversable LT?	N/A	N/A	Flare Traversable RT?	N/A
N/A	Landing Length (in)	N/A	N/A	DWS Provided?	N/A
N/A	Landing Width (in)	N/A	N/A	DWS Contrast?	N/A
N/A	Landing Slope (%)	N/A	N/A	DWS Length (in)	N/A
N/A	Landing X Slope (%)	N/A	N/A	DWS Full Width?	N/A
N/A	Landing Curb? (Y/N)	N/A	N/A	DWS Offset (in)	N/A
N/A	Shared Landing?	N/A			
N/A	Gutter Ponding?	N/A	N/A	Gutter Slope (%)	N/A
N/A	Gutter Lip Ht (in)	0.5	N/A	Gutter X Slope (%)	N/A
N/A	Painted X Walk1?	No	N/A	Painted X Walk2?	N/A
	X Walk 1 Direction	To SW		X Walk 2 Direction	N/A
N/A	X Walk 1 Width (in)	N/A	N/A	X Walk 2 Width (in)	N/A
	X Walk 1 Slope (%)	1.1		X Walk 2 Slope (%)	N/A
	X Walk 1 X Slope (%)	0.6		X Walk 2 X Slope (%)	N/A

N/A	Ramp inside XWalk1?	N/A	N/A	Ramp inside XWalk2?	N/A
	Road Slope (%)	N/A	N/A	Clear Space?	N/A
	Road X Slope (%)	N/A	N/A	Clear Space to XWalk (in)	N/A
N/A	Any Obstructions?	N/A	N/A	Storm Grate/Utility Hazard?	N/A
	Obstruction Type			Storm Grate/Utility Type	
		N/A			N/A
			Yes	Surface Condition? (G/P)	Good

Possible Solutions:

**Remove & Replace Entire Ramp.**

Total Cost: \$ 1850.00
