Access Compliance Report

Public Rights-of-Way

(Curb Ramps)

| Intersection ID: 43762 | Main Street: HELENS_LN | Cross Street: ZIEGLER_LN | Location: NE |

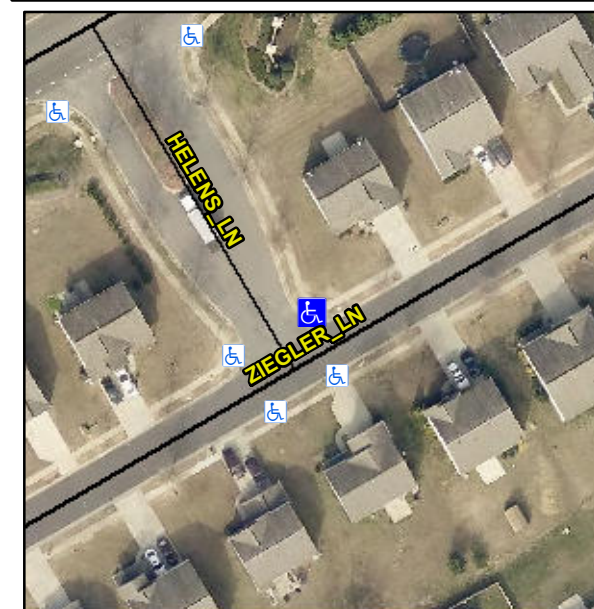
| ADA ID: 301A8525FC0D | Ramp Type: PerpDiag | Initial Pass/Fail: Fail | Overall Compliance: No |
| Severity Score: 21.25 | | | |

R304.5.1, R304.2.2

| Compliance | Description | Data | Compliance | Description | Data |
|---|---|---|---|---|---|
| N/A | Ramp Length (in) | 46.0 | No | Ramp Slope (%) | 10.8 |
| No | Ramp Width (in) | 38.0 | Yes | Ramp XSlope (%) | 1.6 |

Remove & Replace Curb Ramp With Two New Directional Ramps or Equivalent.
