# Access Compliance Report

## Public Rights-of-Way

### (Curb Ramps)

Intersection ID: 14095	Main Street: CAMDEN_RD	Cross Street: W_WORTHINGTON_AV	Location: S
ADA ID: 3024B2EDF8EC	Ramp Type: Perp	Initial Pass/Fail: Fail	Overall Compliance: No
			Severity Score: 13.75

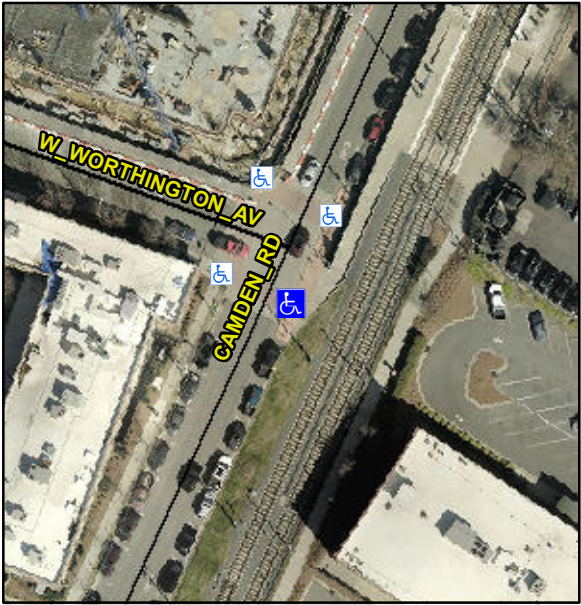
Possible Solutions:		<b>Compliance</b>	<b>Description</b>	<b>Data</b>
	Remove & Replace Entire Ramp.		N/A	Ramp Length (in)	96.0
			Yes	Ramp Width (in)	120.0
			N/A	Flare Type LT	N/A
			N/A	Flare Slope LT (%)	N/A
			N/A	Flare Traversable LT?	N/A
			N/A	Landing Length (in)	N/A
			N/A	Landing Width (in)	N/A
			N/A	Landing Slope (%)	N/A
			N/A	Landing X Slope (%)	N/A
<p>Surveyor Notes:</p> <p>N/A</p> <p>PROW/ADA:</p> <p>R304.2.2, R304.5.3</p>			N/A	Flare Type RT	N/A
			N/A	Flare Slope RT (%)	N/A
			N/A	Flare Traversable RT?	N/A
			N/A	DWS Provided?	N/A
			N/A	DWS Contrast?	N/A
			N/A	DWS Length (in)	N/A
			N/A	DWS Full Width?	N/A
			N/A	DWS Offset (in)	N/A
			N/A	Gutter Ponding?	N/A
			N/A	Gutter Lip Ht (in)	N/A
<p>Total Cost:</p> <p>\$ 1850.00</p>			N/A	Painted X Walk1?	Yes
				X Walk 1 Direction	To NW
			N/A	X Walk 1 Width (in)	121.0

X Walk 1 Slope (%)	1.9
				X Walk 1 X Slope (%)	0.7
			N/A	Ramp inside XWalk1?	Yes
				Road Slope (%)	N/A
				Road X Slope (%)	N/A
			N/A	Any Obstructions?	N/A
				Obstruction Type	
			N/A		N/A
			Yes	Surface Condition? (G/P)	Good
