# Access Compliance Report

## Public Rights-of-Way

### (Curb Ramps)

Intersection ID: 46324	Main Street: ARBOR_VISTA_DR	Cross Street: SENATOR_ROYALL_DR	Location: SE
ADA ID: 303745784F80	Ramp Type: PerpDiag	Initial Pass/Fail: Fail	Overall Compliance: No
Severity Score: 10			
Codes/Mitigation Info/Possible Solution		Field Measurements/Component Compliance

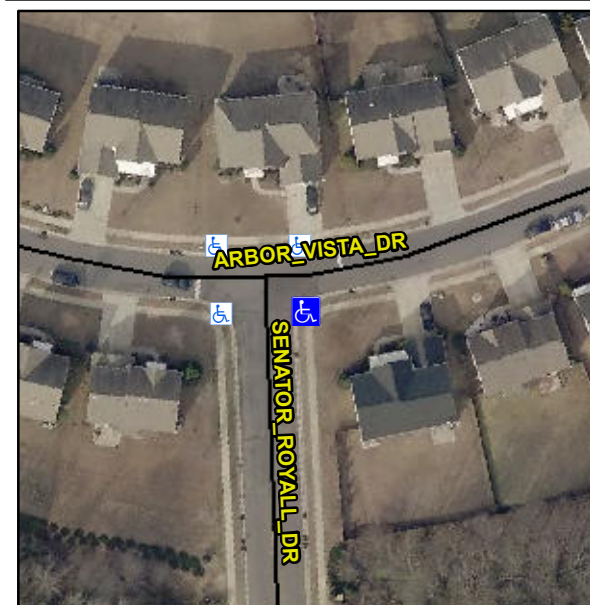
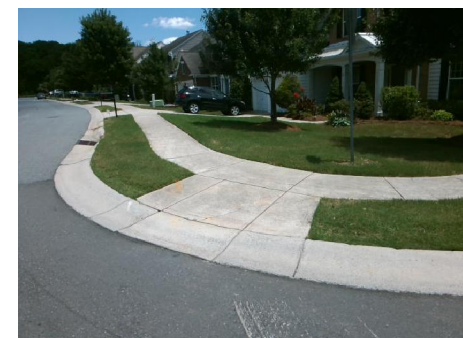
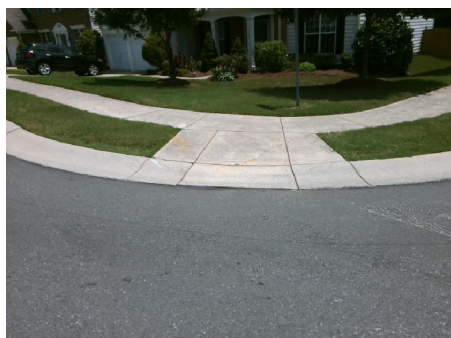
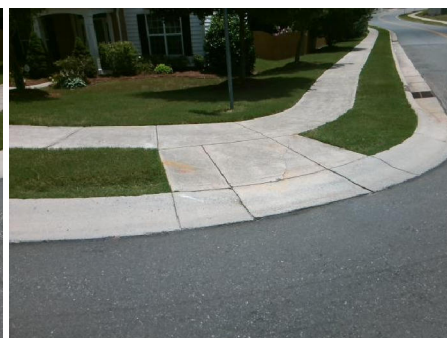
**Not Found, R304.5.1, R304.5.3**

Compliance	Description	Data	Compliance	Description	Data
N/A	Ramp Length (in)	49.0	Yes	Ramp Slope (%)	7.1
No	Ramp Width (in)	41.0	No	Ramp XSlope (%)	4.6
N/A	Flare Type LT	N/A	N/A	Flare Type RT	N/A
N/A	Flare Slope LT (%)	N/A	N/A	Flare Slope RT (%)	N/A
N/A	Flare Traversable LT?	N/A	N/A	Flare Traversable RT?	N/A
N/A	Landing Length (in)	N/A	N/A	DWS Provided?	N/A
N/A	Landing Width (in)	N/A	N/A	DWS Contrast?	N/A
N/A	Landing Slope (%)	N/A	N/A	DWS Length (in)	N/A
N/A	Landing X Slope (%)	N/A	N/A	DWS Full Width?	N/A
N/A	Landing Curb? (Y/N)	N/A	N/A	DWS Offset (in)	N/A
N/A	Shared Landing?	N/A			
N/A	Gutter Ponding?	N/A	N/A	Gutter Slope (%)	N/A
N/A	Gutter Lip Ht (in)	N/A	N/A	Gutter X Slope (%)	N/A
N/A	Painted X Walk1?	No	N/A	Painted X Walk2?	No
	X Walk 1 Direction	To N		X Walk 2 Direction	To W
N/A	X Walk 1 Width (in)	N/A	N/A	X Walk 2 Width (in)	N/A
	X Walk 1 Slope (%)	8.8		X Walk 2 Slope (%)	2.1
	X Walk 1 X Slope (%)	3.2		X Walk 2 X Slope (%)	4.2

N/A	Ramp inside XWalk1?	N/A	N/A	Ramp inside XWalk2?	N/A
	Road Slope (%)	3.6	N/A	Clear Space?	N/A
	Road X Slope (%)	7.6	N/A	Clear Space to XWalk (in)	N/A
N/A	Any Obstructions?	N/A	N/A	Storm Grate/Utility Hazard?	N/A
	Obstruction Type			Storm Grate/Utility Type	
		N/A			N/A
		Yes		Surface Condition? (G/P)	Good

**Remove & Replace Curb Ramp With Two New Directional Ramps or Equivalent.**
