Access Compliance Report

Public Rights-of-Way

(Curb Ramps)

| Intersection ID: 14525 | Main Street: ALBEMARLE_RD | Cross Street: FAULCONBRIDGE_RD | Location: NE |

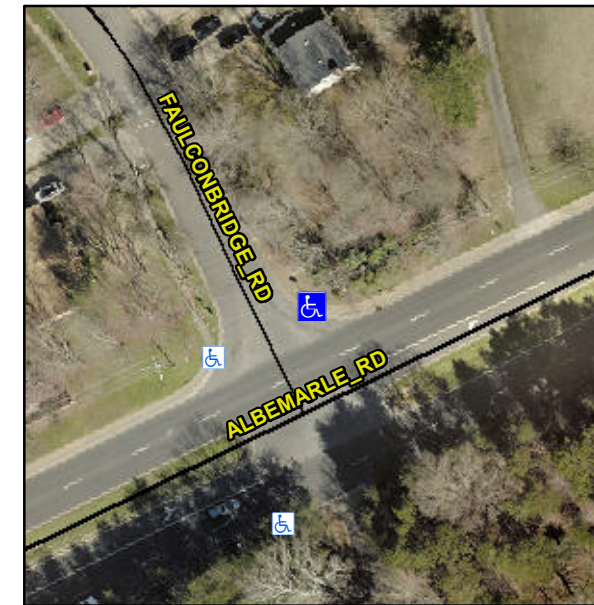
| ADA ID: 303998B08497 | Ramp Type: Perp | Initial Pass/Fail: Fail | Overall Compliance: No |
| | | Severity Score: 12.5 | |

Not Found, R304.2.2

| Compliance | Description | Data | Compliance | Description | Data |
|---|---|---|---|---|---|
| N/A | Ramp Length (in) | 60.5 | No | Ramp Slope (%) | 9.7 |

Possible Solutions:

Remove & Replace Entire Ramp.
