Access Compliance Report

Public Rights-of-Way

(Curb Ramps)

| Intersection ID: 52490 | Main Street: WHITEHALL_EXECUTIVE_CENTER_DR | Cross Street: PRAGUE_LN | Location: | N |

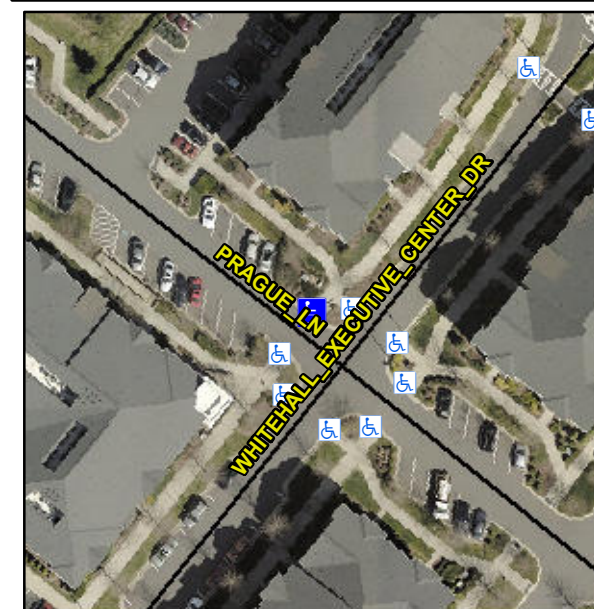
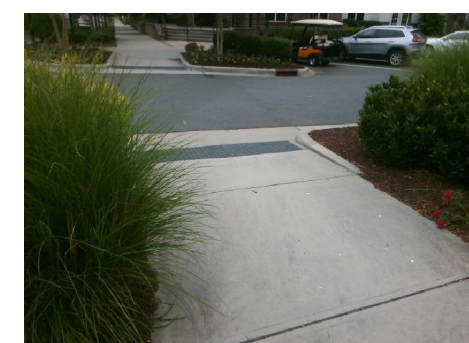
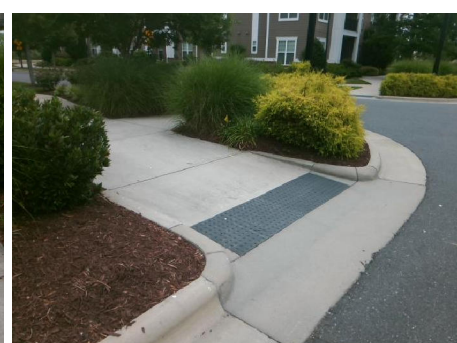
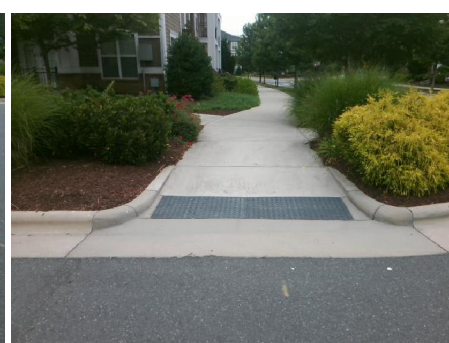
| ADA ID: 304296138CF2 | Ramp Type: Perp | Initial Pass/Fail: Fail | Overall Compliance: No | Severity Score: 12.5 |

Not Found, R304.2.2

| Compliance | Description | Data | Compliance | Description | Data |
|---|---|---|---|---|---|
| N/A | Ramp Length (in) | 69.5 | No | Ramp Slope (%) | 9.0 |

Remove & Replace Entire Ramp.
