Access Compliance Report

Public Rights-of-Way

(Curb Ramps)

| Intersection ID: 10033675 | Main Street: ORCHARD_LAKE_DR | Cross Street: N/A | Location: NE |

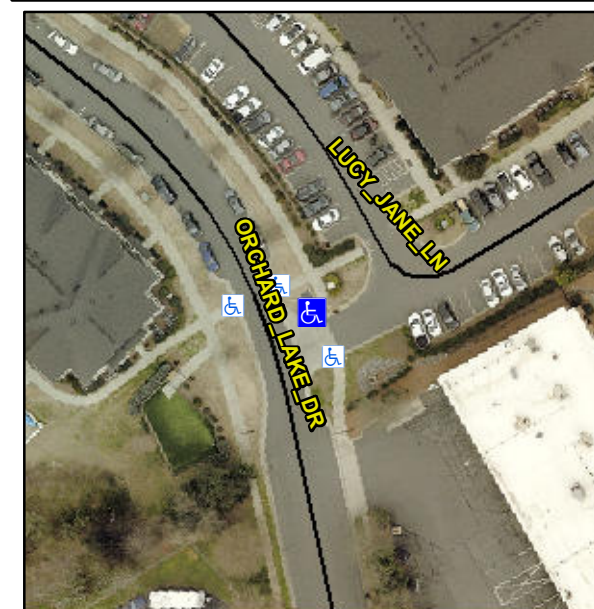
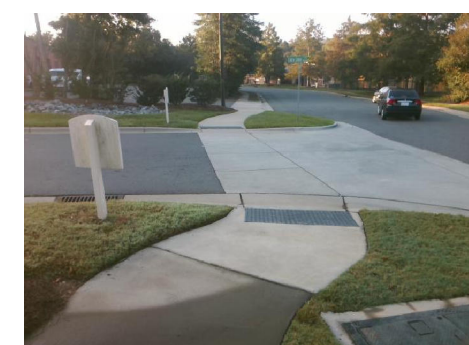
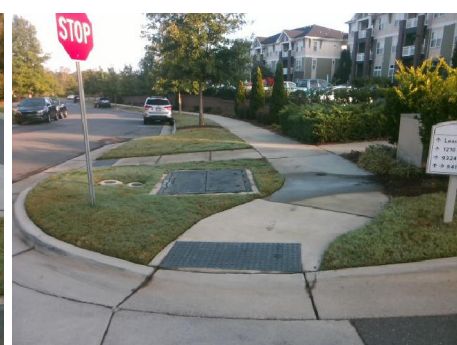
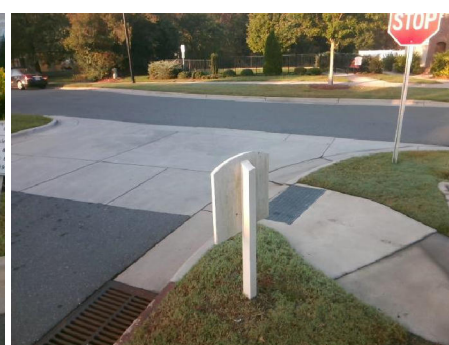
| ADA ID: 304EC5169298 | Ramp Type: Perp | Initial Pass/Fail: Fail | Overall Compliance: No |
| Severity Score: 12.5 | | | |

R304.5.3

| Compliance | Description | Data | Compliance | Description | Data |
|---|---|---|---|---|---|
| Yes | Ramp Width (in) | 60.0 | No | Ramp XSlope (%) | 5.7 |

Possible Solutions:

Remove & Replace Entire Ramp.
