Intersection ID: 50747	Main Street: MONTELENA_DR	Cross Street: ARTESA_CT	Location:	S
ADA ID: 30604BE1DDB2	Ramp Type: PerpDiag	Initial Pass/Fail: Fail	Overall Compliance: No	Severity Score: 8.75

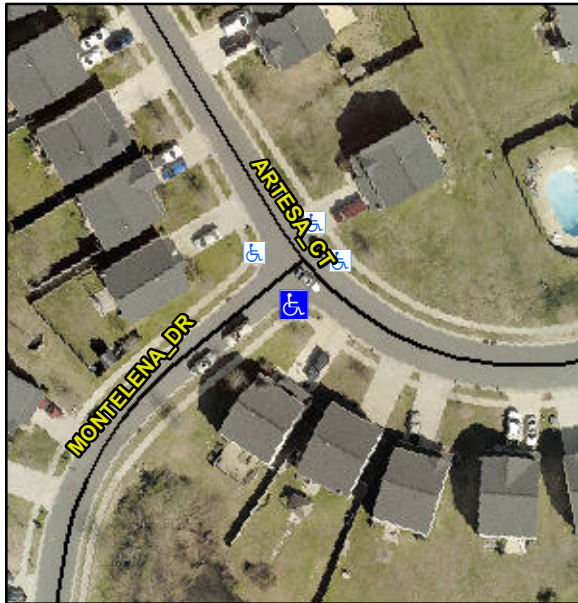
Not Found, R304.5.1

Compliance	Description	Data	Compliance	Description	Data
N/A	Ramp Length (in)	46.5	Yes	Ramp Slope (%)	7.2
No	Ramp Width (in)	46.0	Yes	Ramp XSlope (%)	1.6
N/A	Flare Type LT	N/A	N/A	Flare Type RT	N/A
N/A	Flare Slope LT (%)	N/A	N/A	Flare Slope RT (%)	N/A
N/A	Flare Traversable LT?	N/A	N/A	Flare Traversable RT?	N/A
N/A	Landing Length (in)	N/A	N/A	DWS Provided?	N/A
N/A	Landing Width (in)	N/A	N/A	DWS Contrast?	N/A
N/A	Landing Slope (%)	N/A	N/A	DWS Length (in)	N/A
N/A	Landing X Slope (%)	N/A	N/A	DWS Full Width?	N/A
N/A	Landing Curb? (Y/N)	N/A	N/A	DWS Offset (in)	N/A
N/A	Shared Landing?	N/A			
N/A	Gutter Ponding?	N/A	N/A	Gutter Slope (%)	N/A
N/A	Gutter Lip Ht (in)	N/A	N/A	Gutter X Slope (%)	N/A
N/A	Painted X Walk1?	No	N/A	Painted X Walk2?	No
	X Walk 1 Direction	To NE		X Walk 2 Direction	To NW
N/A	X Walk 1 Width (in)	N/A	N/A	X Walk 2 Width (in)	N/A
	X Walk 1 Slope (%)	2.8		X Walk 2 Slope (%)	4.6
	X Walk 1 X Slope (%)	3.1		X Walk 2 X Slope (%)	1.2

N/A	Ramp inside XWalk1?	N/A	N/A	Ramp inside XWalk2?	N/A
	Road Slope (%)	1.8	N/A	Clear Space?	N/A
	Road X Slope (%)	6.9	N/A	Clear Space to XWalk (in)	N/A
N/A	Any Obstructions?	N/A	N/A	Storm Grate/Utility Hazard?	N/A
	Obstruction Type			Storm Grate/Utility Type	
		N/A			N/A
			Yes	Surface Condition? (G/P)	Good

Remove & Replace Curb Ramp With Two New Directional Ramps or Equivalent.
