# Access Compliance Report

## Public Rights-of-Way

### (Curb Ramps)

Intersection ID: 13442	Main Street: MORRIS_FIELD_DR	Cross Street: AIRPORT_CENTER_PY	Location: S
ADA ID: 30664BC40BB9	Ramp Type: PerpDiag	Initial Pass/Fail: Fail	Overall Compliance: No
Severity Score: 10			
Codes/Mitigation Info/Possible Solution		Field Measurements/Component Compliance

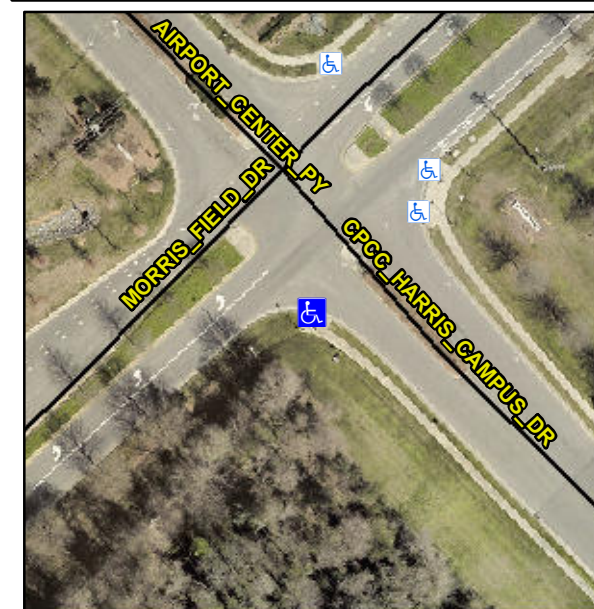
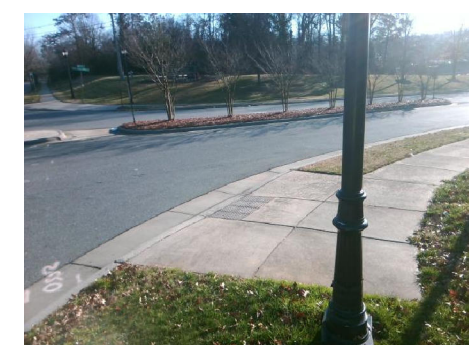
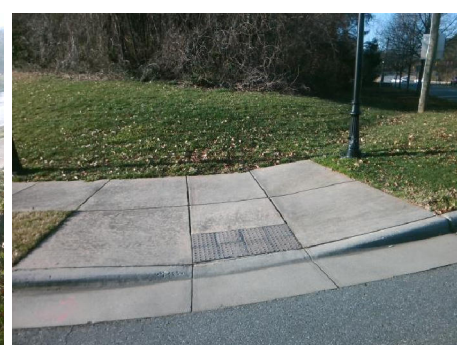
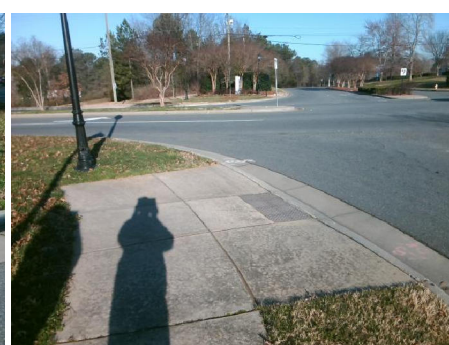
**Not Found, R304.5.1, R304.5.3**

Compliance	Description	Data	Compliance	Description	Data
N/A	Ramp Length (in)	59.0	Yes	Ramp Slope (%)	7.9
No	Ramp Width (in)	47.0	No	Ramp XSlope (%)	3.7
N/A	Flare Type LT	N/A	N/A	Flare Type RT	N/A
N/A	Flare Slope LT (%)	N/A	N/A	Flare Slope RT (%)	N/A
N/A	Flare Traversable LT?	N/A	N/A	Flare Traversable RT?	N/A
N/A	Landing Length (in)	N/A	N/A	DWS Provided?	N/A
N/A	Landing Width (in)	N/A	N/A	DWS Contrast?	N/A
N/A	Landing Slope (%)	N/A	N/A	DWS Length (in)	N/A
N/A	Landing X Slope (%)	N/A	N/A	DWS Full Width?	N/A
N/A	Landing Curb? (Y/N)	N/A	N/A	DWS Offset (in)	N/A
N/A	Shared Landing?	N/A			
N/A	Gutter Ponding?	N/A	N/A	Gutter Slope (%)	N/A
N/A	Gutter Lip Ht (in)	N/A	N/A	Gutter X Slope (%)	N/A
N/A	Painted X Walk1?	No	N/A	Painted X Walk2?	No
	X Walk 1 Direction	To NE		X Walk 2 Direction	To NW
N/A	X Walk 1 Width (in)	N/A	N/A	X Walk 2 Width (in)	N/A
	X Walk 1 Slope (%)	0.8		X Walk 2 Slope (%)	3.9
	X Walk 1 X Slope (%)	3.9		X Walk 2 X Slope (%)	0.1

N/A	Ramp inside XWalk1?	N/A	N/A	Ramp inside XWalk2?	N/A
	Road Slope (%)	3.5	N/A	Clear Space?	N/A
	Road X Slope (%)	1.4	N/A	Clear Space to XWalk (in)	N/A
N/A	Any Obstructions?	N/A	N/A	Storm Grate/Utility Hazard?	N/A
	Obstruction Type			Storm Grate/Utility Type	
		N/A			N/A
			Yes	Surface Condition? (G/P)	Good

**Remove & Replace Curb Ramp With Two New Directional Ramps or Equivalent.**
