# Access Compliance Report

## Public Rights-of-Way

### (Curb Ramps)

Intersection ID: 7211	Main Street: KINGVILLE_DR	Cross Street: NORTHRIDGE_VILLAGE_DR	Location: E
ADA ID: 3087C0459C80	Ramp Type: PerpDiag	Initial Pass/Fail: Fail	Overall Compliance: No
Codes/Mitigation Info/Possible Solution		Field Measurements/Component Compliance	
Severity Score: 21.25

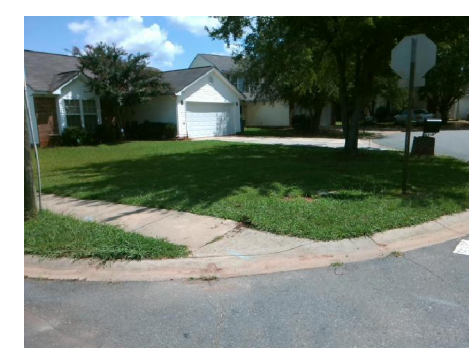
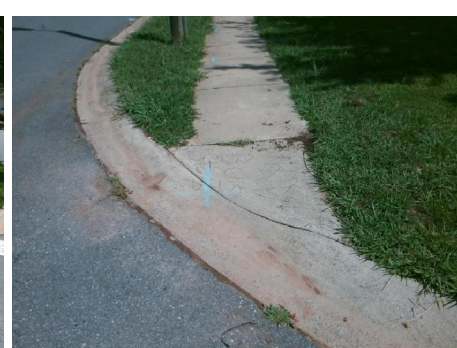
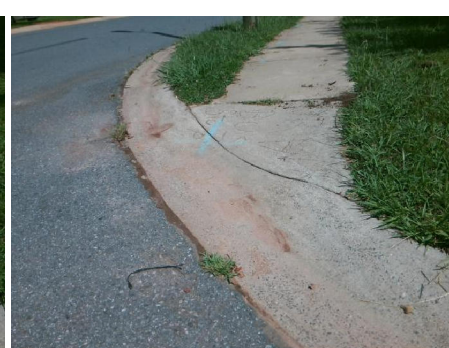
X Walk 1 Direction	To NW		X Walk 2 Direction	To S
			N/A	X Walk 1 Width (in)	N/A	N/A	X Walk 2 Width (in)	N/A
				X Walk 1 Slope (%)	1.1		X Walk 2 Slope (%)	1.1
				X Walk 1 X Slope (%)	0.5		X Walk 2 X Slope (%)	1.2
			N/A	Ramp inside XWalk1?	N/A	N/A	Ramp inside XWalk2?	N/A
<p>Total Cost:</p> <p>\$ 3200.00</p>				Road Slope (%)	0.2	N/A	Clear Space?	N/A
				Road X Slope (%)	0.1	N/A	Clear Space to XWalk (in)	N/A
			N/A	Any Obstructions?	N/A	N/A	Storm Grate/Utility Hazard?	N/A
				Obstruction Type			Storm Grate/Utility Type	
					N/A			N/A
						Yes	Surface Condition? (G/P)	Good
