Access Compliance Report Public Rights-of-Way (Curb Ramps)

Intersection ID: 42401Main Street: GRIERS_GROVE_RDCross Street: MCALLISTER_DRLocation: WADA ID: 308BC5FEAB8FRamp Type: PerpInitial Pass/Fail: FailOverall Compliance: NoSeverity Score: 30

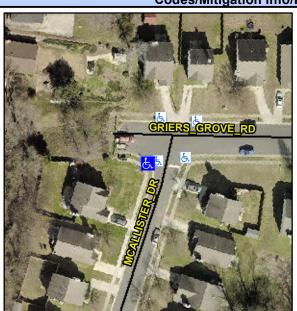
| 1 0331bic Ocidiioii | |
|---|---|
| Not Found, R304.5.1, R304.2.2 | N/ |

| Comp | liance Description | Data | Comp | liance Description | Data |
|---|---|---|---|---|---|
| N/A | Ramp Length (in) | 52.0 | No | Ramp Slope (%) | 8.4 |
| No | Ramp Width (in) | 34.0 | Yes | Ramp XSlope (%) | 1.9 |

| 1 0331bic Ocidiioii | |
|---|---|
| Remove & Replace Entire Ramp. | N |
