## Access Compliance Report Public Rights-of-Way (Curb Ramps)

Intersection ID: 5151 Main Street: HAYBRIDGE\_RD Cross Street: RINDLE\_CT Location: NW

ADA ID: 3098E8BBABFA Ramp Type: BlendTrans1 Initial Pass/Fail: Fail Overall Compliance: No Severity Score: 8.75

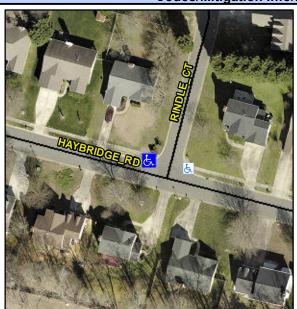
Field Measurements/Component Compliance Compliance Description Data Compliance Description Data Yes BlendTrans Slope (%) N/A Ramp Length (in) 37.0 3.6 Yes No Ramp Width (in) 44.0 BlendTrans XSlope (%) 1.7 N/A N/A Flare Type LT N/A Flare Type RT N/A N/A Flare Slope LT (%) N/A N/A Flare Slope RT (%) N/A N/A Flare Traversable LT? N/A N/A Flare Traversable RT? N/A N/A Landing Length (in) N/A N/A **DWS Provided?** N/A N/A Landing Width (in) N/A N/A **DWS Contrast?** N/A N/A N/A N/A Landing Slope (%) DWS Length (in) N/A N/A Landing X Slope (%) N/A N/A DWS Full Width? N/A N/A Landing Curb? (Y/N) N/A N/A DWS Offset (in) N/A N/A N/A Shared Landing? N/A **Gutter Ponding?** N/A N/A Gutter Slope (%) N/A N/A Gutter Lip Ht (in) N/A N/A Gutter X Slope (%) N/A N/A Painted X Walk1? No N/A Painted X Walk2? N/A X Walk 1 Direction To E X Walk 2 Direction N/A N/A X Walk 1 Width (in) X Walk 2 Width (in) N/A X Walk 1 Slope (%) 3.8 X Walk 2 Slope (%) N/A X Walk 1 X Slope (%) 2.2 X Walk 2 X Slope (%) N/A N/A N/A Ramp inside XWalk2? N/A Ramp inside XWalk1? N/A Road Slope (%) 2.2 Clear Space? N/A N/A Road X Slope (%) 3.8 Clear Space to XWalk (in) N/A N/A N/A N/A Any Obstructions? Storm Grate/Utility Hazard? N/A **Obstruction Type** Storm Grate/Utility Type N/A N/A Yes Surface Condition? (G/P) Good N/A Curb Slope (%) 1.6

Remove & Replace Curb Ramp With Two New Directional Ramps or Equivalent.
