# Access Compliance Report

## Public Rights-of-Way

### (Curb Ramps)

Intersection ID: N/A	Main Street: BALLANTYNE CORPORATE PCross Street: N/A	Location: NW
ADA ID: 30A00B790FBD	Ramp Type: Directional1	Initial Pass/Fail: Fail
	Overall Compliance: No	Severity Score: 13.75
Codes/Mitigation Info/Possible Solution		Field Measurements/Component Compliance

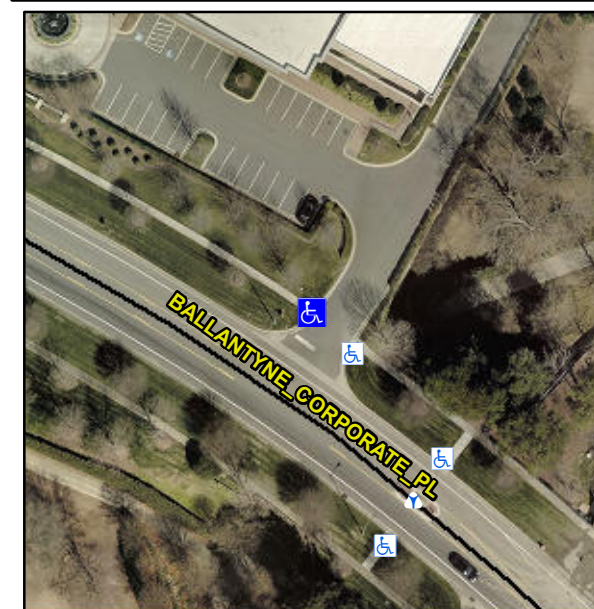
Compliance	Description	Data	Compliance	Description	Data
N/A	Ramp Length (in)	78.0	N/A	Grade Break?	N/A
Yes	Ramp Width (in)	48.0	N/A	Grade Break Slope (%)	0.0
No	Ramp Slope (%)	8.8	N/A	Grade Break XSlope (%)	0.0
No	Ramp XSlope (%)	2.3			
N/A	Flare Type LT	N/A	N/A	Flare Type RT	N/A
N/A	Flare Slope LT (%)	N/A	N/A	Flare Slope RT (%)	0.0
N/A	Flare Traversable LT?	N/A	N/A	Flare Traversable RT?	N/A
N/A	Landing Length (in)	0.0	N/A	DWS Provided?	N/A
N/A	Landing Width (in)	0.0	N/A	DWS Contrast?	N/A
N/A	Landing Slope (%)	0.0	N/A	DWS Length (in)	N/A
N/A	Landing X Slope (%)	0.0	N/A	DWS Full Width?	N/A
N/A	Landing Curb? (Y/N)	N/A	N/A	DWS Offset LT (in)	N/A
N/A	Shared Landing?	N/A	N/A	DWS Offset RT (in)	N/A
N/A	Gutter Ponding?	0.0	N/A	Gutter Slope (%)	N/A
N/A	Gutter Lip Ht (in)	0.0	N/A	Gutter X Slope (%)	N/A
N/A	Painted X Walk1?	No		Road Slope (%)	2.6
	X Walk 1 Direction	To SE		Road X Slope (%)	2.8
	X Walk 1 Width (in)	N/A		Clear Space?	N/A

X Walk 1 Slope (%)	2.6	N/A	Clear Space to XWalk (in)	N/A
	X Walk 1 X Slope (%)	2.8	N/A	Storm Grate/Utility Hazard?	N/A
N/A	Ramp inside XWalk1?	N/A		Storm Grate/Utility Type	
N/A	Any Obstructions?	N/A			N/A
	Obstruction Type		Yes	Surface Condition? (G/P)	Good
			N/A	Curb Slope (%)	8.2

**Remove & Replace Entire Ramp.**

**R304.2.2, R304.5.3**
