Access Compliance Report

Public Rights-of-Way

(Curb Ramps)

Intersection ID: 26367	Main Street: BEVINGTON_PL	Cross Street: GLYNMOOR_LAKES_DR	Location:	N
ADA ID: 30BA36B95796	Ramp Type: PerpDiag	Initial Pass/Fail: Fail	Overall Compliance: No	Severity Score: 10
Codes/Mitigation Info/Possible Solution		Field Measurements/Component Compliance

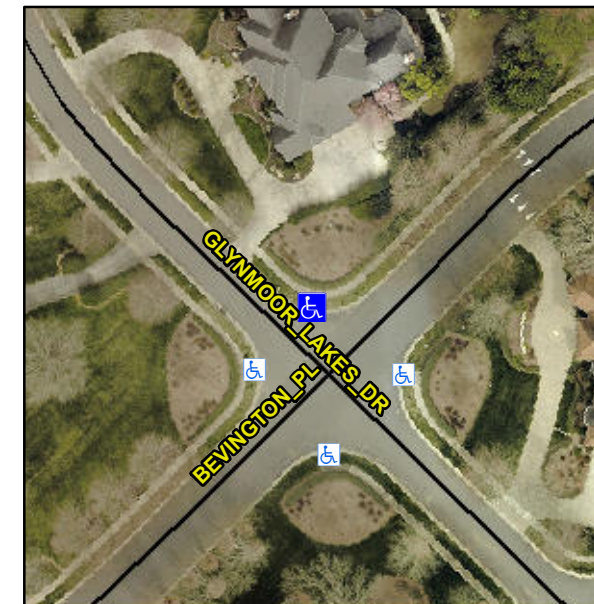
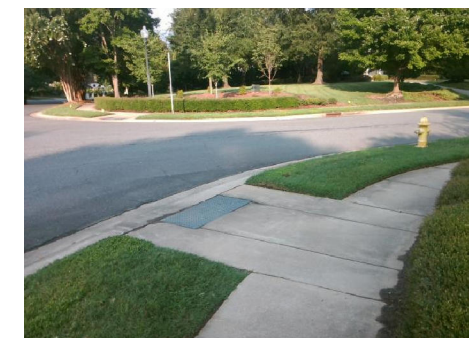
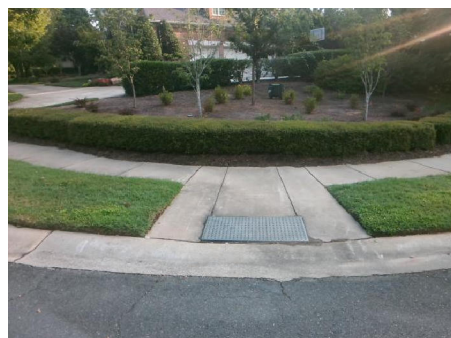
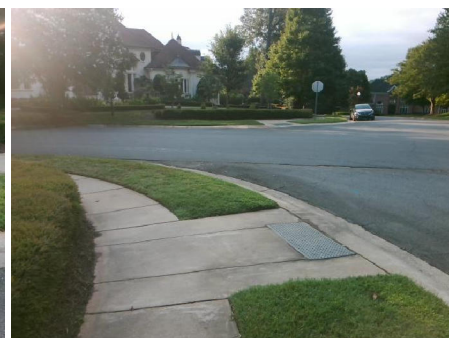
Not Found, R304.5.1, R304.5.3

Compliance	Description	Data	Compliance	Description	Data
N/A	Ramp Length (in)	119.0	Yes	Ramp Slope (%)	6.0
No	Ramp Width (in)	36.0	No	Ramp XSlope (%)	3.2
N/A	Flare Type LT	N/A	N/A	Flare Type RT	N/A
N/A	Flare Slope LT (%)	N/A	N/A	Flare Slope RT (%)	N/A
N/A	Flare Traversable LT?	N/A	N/A	Flare Traversable RT?	N/A
N/A	Landing Length (in)	N/A	N/A	DWS Provided?	N/A
N/A	Landing Width (in)	N/A	N/A	DWS Contrast?	N/A
N/A	Landing Slope (%)	N/A	N/A	DWS Length (in)	N/A
N/A	Landing X Slope (%)	N/A	N/A	DWS Full Width?	N/A
N/A	Landing Curb? (Y/N)	N/A	N/A	DWS Offset (in)	N/A
N/A	Shared Landing?	N/A			
N/A	Gutter Ponding?	N/A	N/A	Gutter Slope (%)	N/A
N/A	Gutter Lip Ht (in)	N/A	N/A	Gutter X Slope (%)	N/A
N/A	Painted X Walk1?	No	N/A	Painted X Walk2?	No
	X Walk 1 Direction	To SW		X Walk 2 Direction	To SE
N/A	X Walk 1 Width (in)	N/A	N/A	X Walk 2 Width (in)	N/A
	X Walk 1 Slope (%)	3.8		X Walk 2 Slope (%)	2.1
	X Walk 1 X Slope (%)	2.1		X Walk 2 X Slope (%)	1.7

N/A	Ramp inside XWalk1?	N/A	N/A	Ramp inside XWalk2?	N/A
	Road Slope (%)	2.1	N/A	Clear Space?	N/A
	Road X Slope (%)	2.9	N/A	Clear Space to XWalk (in)	N/A
N/A	Any Obstructions?	N/A	N/A	Storm Grate/Utility Hazard?	N/A
	Obstruction Type			Storm Grate/Utility Type	
		N/A			N/A
		Yes		Surface Condition? (G/P)	Good

Remove & Replace Curb Ramp With Two New Directional Ramps or Equivalent.
