# Access Compliance Report

## Public Rights-of-Way

### (Curb Ramps)

Intersection ID: 47837	Main Street: CACTUS_VALLEY_RD	Cross Street: DRAGONFLY_LN	Location: SW
ADA ID: 30BCE3F9B385	Ramp Type: Perp	Initial Pass/Fail: Fail	Overall Compliance: No
Codes/Mitigation Info/Possible Solution		Field Measurements/Component Compliance	
Severity Score: 21.25

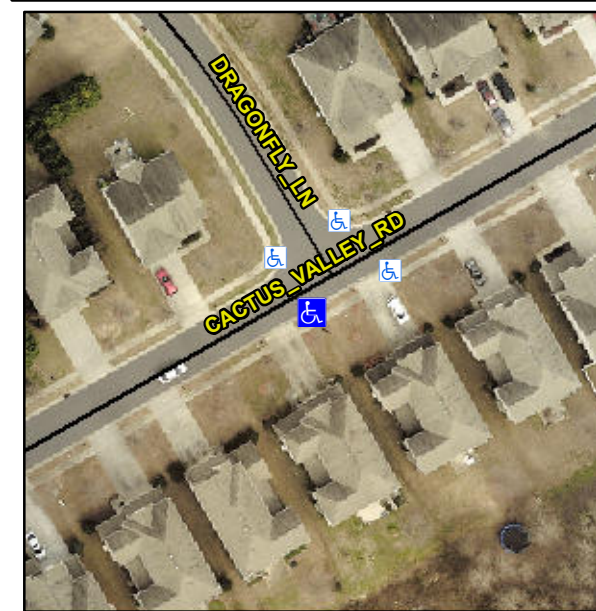
Compliance	Description	Data	Compliance	Description	Data
N/A	Ramp Length (in)	49.0	No	Ramp Slope (%)	8.4
No	Ramp Width (in)	45.5	Yes	Ramp XSlope (%)	0.0
N/A	Flare Type LT	N/A	N/A	Flare Type RT	N/A
N/A	Flare Slope LT (%)	N/A	N/A	Flare Slope RT (%)	N/A
N/A	Flare Traversable LT?	N/A	N/A	Flare Traversable RT?	N/A
N/A	Landing Length (in)	N/A	N/A	DWS Provided?	N/A
N/A	Landing Width (in)	N/A	N/A	DWS Contrast?	N/A
N/A	Landing Slope (%)	N/A	N/A	DWS Length (in)	N/A
N/A	Landing X Slope (%)	N/A	N/A	DWS Full Width?	N/A
N/A	Landing Curb? (Y/N)	N/A	N/A	DWS Offset (in)	N/A
N/A	Shared Landing?	N/A			
N/A	Gutter Ponding?	N/A	N/A	Gutter Slope (%)	N/A
N/A	Gutter Lip Ht (in)	N/A	N/A	Gutter X Slope (%)	N/A
N/A	Painted X Walk1?	No	N/A	Painted X Walk2?	N/A
	X Walk 1 Direction	To NW		X Walk 2 Direction	N/A
N/A	X Walk 1 Width (in)	N/A	N/A	X Walk 2 Width (in)	N/A
	X Walk 1 Slope (%)	2.9		X Walk 2 Slope (%)	N/A
	X Walk 1 X Slope (%)	0.6		X Walk 2 X Slope (%)	N/A

N/A	Ramp inside XWalk1?	N/A	N/A	Ramp inside XWalk2?	N/A
	Road Slope (%)	N/A	N/A	Clear Space?	N/A
	Road X Slope (%)	N/A	N/A	Clear Space to XWalk (in)	N/A
N/A	Any Obstructions?	N/A	N/A	Storm Grate/Utility Hazard?	N/A
	Obstruction Type			Storm Grate/Utility Type	
		N/A			N/A
			Yes	Surface Condition? (G/P)	Good

**Remove & Replace Entire Ramp.**

**R304.5.1, R304.2.2**
