# Access Compliance Report

## Public Rights-of-Way

### (Curb Ramps)

Intersection ID: 15299	Main Street: OAKCREST_PL	Cross Street: POINDEXTER_DR	Location: S
ADA ID: 30BF49C5D810	Ramp Type: PerpDiag	Initial Pass/Fail: Fail	Overall Compliance: No
Severity Score: 37.5			
Codes/Mitigation Info/Possible Solution		Field Measurements/Component Compliance

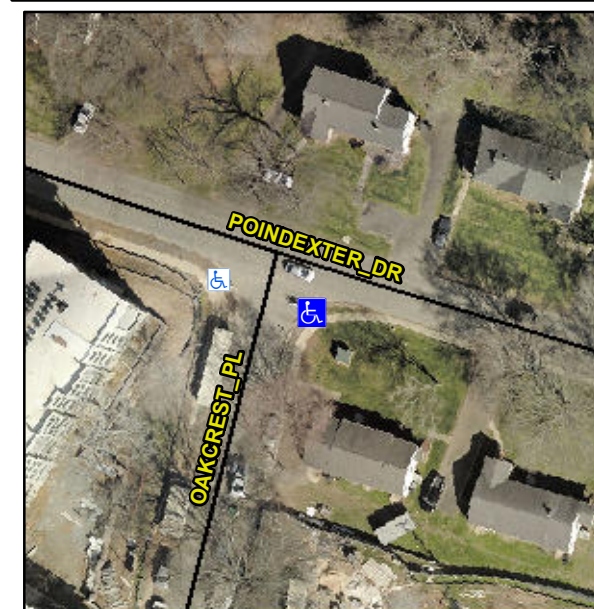
**Not Found, R304.2.2, R304.5.3**

Compliance	Description	Data	Compliance	Description	Data
N/A	Ramp Length (in)	108.0	No	Ramp Slope (%)	10.2
Yes	Ramp Width (in)	68.0	No	Ramp XSlope (%)	8.4
N/A	Flare Type LT	N/A	N/A	Flare Type RT	N/A
N/A	Flare Slope LT (%)	N/A	N/A	Flare Slope RT (%)	N/A
N/A	Flare Traversable LT?	N/A	N/A	Flare Traversable RT?	N/A
N/A	Landing Length (in)	N/A	N/A	DWS Provided?	N/A
N/A	Landing Width (in)	N/A	N/A	DWS Contrast?	N/A
N/A	Landing Slope (%)	N/A	N/A	DWS Length (in)	N/A
N/A	Landing X Slope (%)	N/A	N/A	DWS Full Width?	N/A
N/A	Landing Curb? (Y/N)	N/A	N/A	DWS Offset (in)	N/A
N/A	Shared Landing?	N/A			
N/A	Gutter Ponding?	N/A	N/A	Gutter Slope (%)	N/A
N/A	Gutter Lip Ht (in)	N/A	N/A	Gutter X Slope (%)	N/A
N/A	Painted X Walk1?	No	N/A	Painted X Walk2?	No
	X Walk 1 Direction	To NE		X Walk 2 Direction	To NW
N/A	X Walk 1 Width (in)	N/A	N/A	X Walk 2 Width (in)	N/A
	X Walk 1 Slope (%)	7.3		X Walk 2 Slope (%)	4.8
	X Walk 1 X Slope (%)	4.5		X Walk 2 X Slope (%)	6.4

N/A	Ramp inside XWalk1?	N/A	N/A	Ramp inside XWalk2?	N/A
	Road Slope (%)	7.1	N/A	Clear Space?	N/A
	Road X Slope (%)	3.3	N/A	Clear Space to XWalk (in)	N/A
N/A	Any Obstructions?	N/A	N/A	Storm Grate/Utility Hazard?	N/A
	Obstruction Type			Storm Grate/Utility Type	
		N/A			N/A
			Yes	Surface Condition? (G/P)	Good

**Remove & Replace Curb Ramp With Two New Directional Ramps or Equivalent.**

Total Cost: \$ 3200.00
