Access Compliance Report

Public Rights-of-Way

(Curb Ramps)

| Intersection ID: 14049 | Main Street: CLEMENT_AV | Cross Street: PARK_DR | Location: | N |

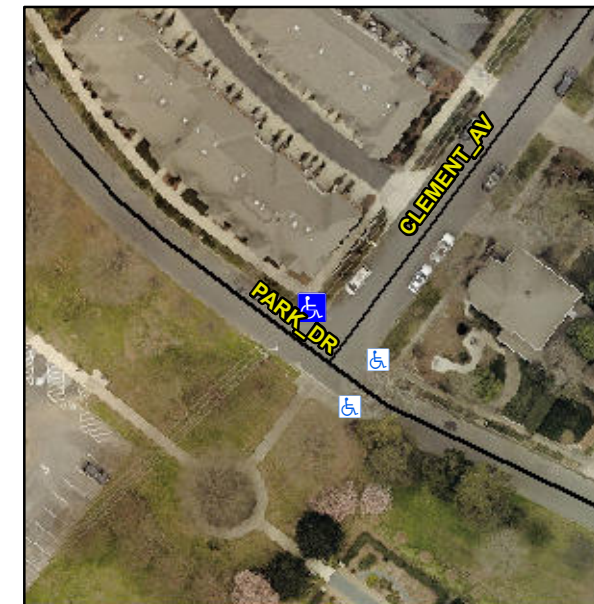
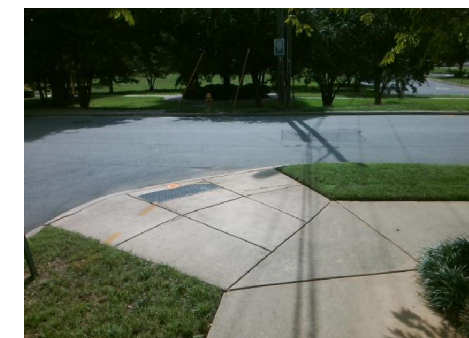
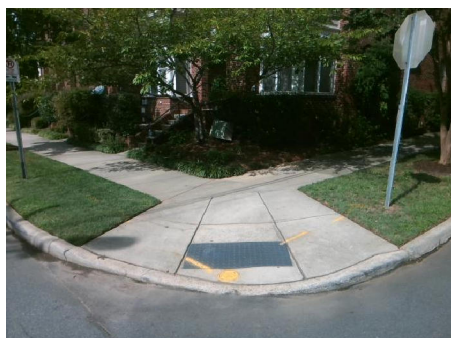
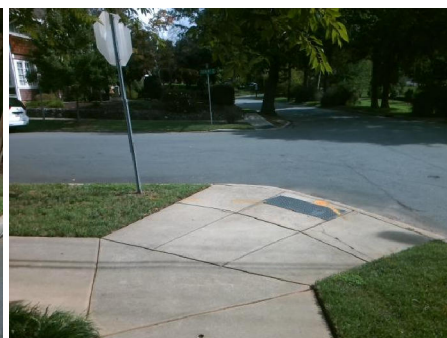
| ADA ID: 30C868844C61 | Ramp Type: PerpDiag | Initial Pass/Fail: Fail | Overall Compliance: No | Severity Score: 22.5 |

Not Found, R304.5.1, R304.2.2, R304.5.3

| Compliance | Description | Data | Compliance | Description | Data |
|---|---|---|---|---|---|
| N/A | Ramp Length (in) | 53.0 | No | Ramp Slope (%) | 8.7 |
| No | Ramp Width (in) | 43.0 | No | Ramp XSlope (%) | 3.4 |

Remove & Replace Curb Ramp With Two New Directional Ramps or Equivalent.
