# Access Compliance Report

## Public Rights-of-Way

### (Curb Ramps)

Intersection ID: N/A	Main Street: BEREWICK COMMONS PKY	Cross Street: LANGWELL LN	Location: NE
ADA ID: 30D80752DDEA	Ramp Type: Perp	Initial Pass/Fail: Fail	Overall Compliance: No
Severity Score: 12.5			
Codes/Mitigation Info/Possible Solution		Field Measurements/Component Compliance

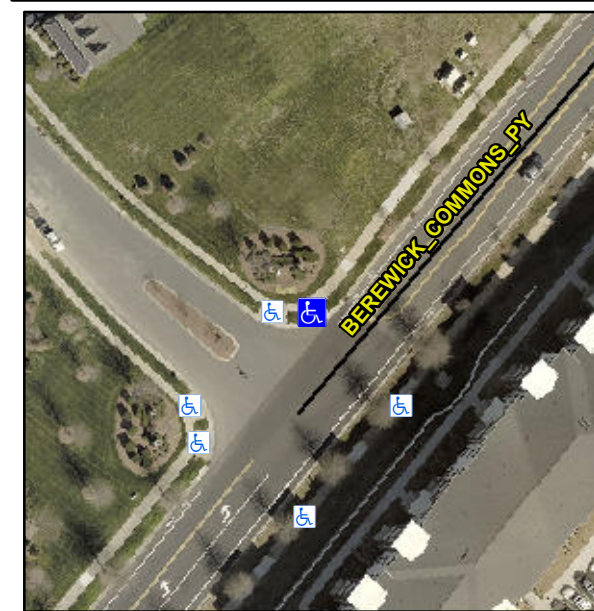
PROW/ADA:

**Not Found, R304.2.2**

Compliance	Description	Data	Compliance	Description	Data
N/A	Ramp Length (in)	79.0	No	Ramp Slope (%)	8.6
Yes	Ramp Width (in)	48.0	Yes	Ramp XSlope (%)	0.0
N/A	Flare Type LT	N/A	N/A	Flare Type RT	N/A
N/A	Flare Slope LT (%)	N/A	N/A	Flare Slope RT (%)	N/A
N/A	Flare Traversable LT?	N/A	N/A	Flare Traversable RT?	N/A
N/A	Landing Length (in)	N/A	N/A	DWS Provided?	N/A
N/A	Landing Width (in)	N/A	N/A	DWS Contrast?	N/A
N/A	Landing Slope (%)	N/A	N/A	DWS Length (in)	N/A
N/A	Landing X Slope (%)	N/A	N/A	DWS Full Width?	N/A
N/A	Landing Curb? (Y/N)	N/A	N/A	DWS Offset (in)	N/A
N/A	Shared Landing?	N/A			
N/A	Gutter Ponding?	N/A	N/A	Gutter Slope (%)	N/A
N/A	Gutter Lip Ht (in)	N/A	N/A	Gutter X Slope (%)	N/A
N/A	Painted X Walk1?	No	N/A	Painted X Walk2?	N/A
	X Walk 1 Direction	To SE		X Walk 2 Direction	N/A
N/A	X Walk 1 Width (in)	N/A	N/A	X Walk 2 Width (in)	N/A
	X Walk 1 Slope (%)	5.3		X Walk 2 Slope (%)	N/A
	X Walk 1 X Slope (%)	0.7		X Walk 2 X Slope (%)	N/A

N/A	Ramp inside XWalk1?	N/A	N/A	Ramp inside XWalk2?	N/A
	Road Slope (%)	N/A	N/A	Clear Space?	N/A
	Road X Slope (%)	N/A	N/A	Clear Space to XWalk (in)	N/A
N/A	Any Obstructions?	N/A	N/A	Storm Grate/Utility Hazard?	N/A
	Obstruction Type			Storm Grate/Utility Type	
		N/A			N/A
			Yes	Surface Condition? (G/P)	Good

Possible Solutions:

**Remove & Replace Entire Ramp.**

Total Cost: \$ 1850.00
