Access Compliance Report

Public Rights-of-Way

(Curb Ramps)

Intersection ID: 11368	Main Street: ERSKINE_DR	Cross Street: SHAMROCK_DR	Location: NE
ADA ID: 30E1C3ACF690	Ramp Type: Perp	Initial Pass/Fail: Fail	Overall Compliance: No
			Severity Score: 21.25

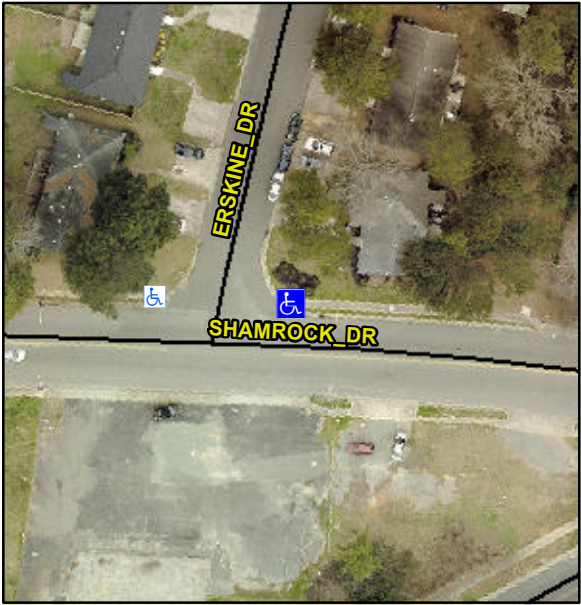
Possible Solutions:		Compliance	Description	Data
	Remove & Replace Entire Ramp.		N/A	Ramp Length (in)	22.0
			No	Ramp Width (in)	45.0
			N/A	Flare Type LT	N/A
			N/A	Flare Slope LT (%)	N/A
			N/A	Flare Traversable LT?	N/A
			N/A	Landing Length (in)	N/A
			N/A	Landing Width (in)	N/A
			N/A	Landing Slope (%)	N/A
			N/A	Landing X Slope (%)	N/A
<p>Surveyor Notes:</p> <p>N/A</p>			N/A	Landing Curb? (Y/N)	N/A
			N/A	Shared Landing?	N/A
			N/A	Gutter Ponding?	N/A
			N/A	Gutter Lip Ht (in)	1.5
			N/A	Painted X Walk1?	No
				X Walk 1 Direction	To W
			N/A	X Walk 1 Width (in)	N/A
				X Walk 1 Slope (%)	2.7
				X Walk 1 X Slope (%)	4.8
			N/A	Ramp inside XWalk1?	N/A
<p>PROW/ADA:</p> <p>Not Found, R304.5.1, R304.5.3</p>			N/A	Road Slope (%)	N/A
				Road X Slope (%)	N/A
			N/A	Any Obstructions?	N/A
				Obstruction Type	
			N/A		
<p>Street 1 Name</p> <p>Stop Condition-Street 2</p> <p>Street 2 Name</p> <p>Stop Condition-Street 1</p>	ERSKINE DR

StopSign				
	N/A				
	N/A				
<p>Total Cost:</p>	\$ 1850.00				
<p>Compliance</p>			N/A		N/A
			Yes	Ramp Slope (%)	6.6
			No	Ramp XSlope (%)	5.8
			N/A	Flare Type RT	N/A
			N/A	Flare Slope RT (%)	N/A
			N/A	Flare Traversable RT?	N/A
			N/A	DWS Provided?	N/A
			N/A	DWS Contrast?	N/A
			N/A	DWS Length (in)	N/A
			N/A	DWS Full Width?	N/A
<p>Compliance</p>			N/A	DWS Offset (in)	N/A
			N/A		
			N/A	Gutter Slope (%)	N/A
			N/A	Gutter X Slope (%)	N/A
			N/A	Painted X Walk2?	N/A
				X Walk 2 Direction	N/A
			N/A	X Walk 2 Width (in)	N/A
				X Walk 2 Slope (%)	N/A
				X Walk 2 X Slope (%)	N/A
			N/A	Ramp inside XWalk2?	N/A
<p>Compliance</p>			N/A	Clear Space?	N/A
			N/A	Clear Space to XWalk (in)	N/A
			N/A	Storm Grate/Utility Hazard?	N/A
				Storm Grate/Utility Type	
			N/A		N/A
			Yes	Surface Condition? (G/P)	Good
