Access Compliance Report Public Rights-of-Way (Curb Ramps)

Intersection ID: 30467 Main Street: PLANTERS_ROW_DR Cross Street: SPRING_FROST_CT Location: SW

ADA ID: 30F0E2F8FF96 Ramp Type: PerpDiag Initial Pass/Fail: Fail Overall Compliance: No Severity Score: 17.5

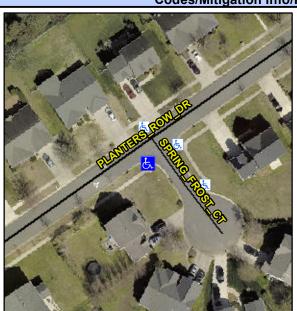
Compliance Description Data Compliance Description Data Yes N/A Ramp Length (in) 69.0 Ramp Slope (%) 6.0 Yes Ramp XSlope (%) No Ramp Width (in) 32.0 1.0 N/A N/A Flare Type LT N/A Flare Type RT N/A N/A N/A N/A Flare Slope RT (%) N/A Flare Slope LT (%) N/A Flare Traversable LT? N/A N/A Flare Traversable RT? N/A N/A N/A N/A **DWS Provided?** N/A Landing Length (in) N/A Landing Width (in) N/A N/A **DWS Contrast?** N/A N/A N/A N/A Landing Slope (%) DWS Length (in) N/A N/A Landing X Slope (%) N/A N/A DWS Full Width? N/A N/A Landing Curb? (Y/N) N/A N/A DWS Offset (in) N/A N/A N/A Shared Landing? N/A Gutter Ponding? N/A N/A Gutter Slope (%) N/A N/A Gutter Lip Ht (in) N/A N/A Gutter X Slope (%) N/A N/A Painted X Walk1? No N/A Painted X Walk2? No X Walk 1 Direction To NE X Walk 2 Direction To NW N/A N/A N/A X Walk 1 Width (in) X Walk 2 Width (in) N/A X Walk 1 Slope (%) 2.5 X Walk 2 Slope (%) 0.0 X Walk 1 X Slope (%) 1.5 X Walk 2 X Slope (%) 2.0 N/A N/A N/A Ramp inside XWalk2? N/A Ramp inside XWalk1? Road Slope (%) 0.5 N/A Clear Space? N/A N/A Road X Slope (%) 2.8 Clear Space to XWalk (in) N/A N/A N/A N/A Any Obstructions? Storm Grate/Utility Hazard? N/A **Obstruction Type** Storm Grate/Utility Type N/A N/A

Remove & Replace Curb Ramp With Two New Directional Ramps or Equivalent.
