# Access Compliance Report

## Public Rights-of-Way

### (Curb Ramps)

| Intersection ID: 51356 | Main Street: BRENTMOOR_DR | Cross Street: PEARL_ST | Location: W |

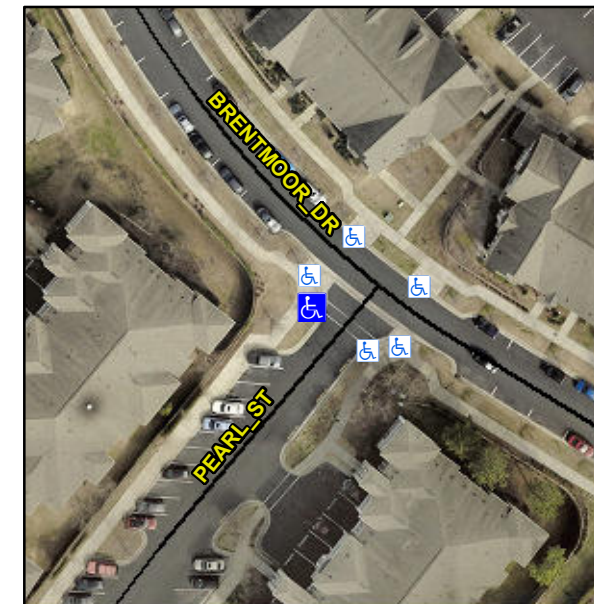
| ADA ID: 30F0EB9CC43A | Ramp Type: BlendTrans1 | Initial Pass/Fail: Pass | Overall Compliance: No |

**R305.2, R304.5.3**

| Compliance | Description | Data | Compliance | Description | Data |
|---|---|---|---|---|---|
| N/A | Landing Curb? (Y/N) | No | No | DWS Offset (in) | 3.0 |
| Yes | Gutter Lip Ht (in) | 0.0 | No | Gutter X Slope (%) | 2.8 |

**Remove & Replace Detectable Warning System. Remove & Replace Gutter.**

Total Cost: \$ 1550.00
