## Access Compliance Report Public Rights-of-Way (Curb Ramps)

Intersection ID: 31200 Main Street: OAKTON\_GLEN\_CT Cross Street: OAKTON\_HUNT\_DR Location: NE
ADA ID: 30F6CCCEB8C2 Ramp Type: PerpDiag Initial Pass/Fail: Fail Overall Compliance: No Severity Score: 13.75

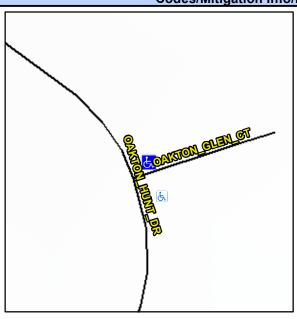
Field Measurements/Component Compliance					
Compliance Description		Data	Comp	liance Description	Data
N/A	Ramp Length (in)	48.0	No	Ramp Slope (%)	10.7
Yes	Ramp Width (in)	48.0	No	Ramp XSlope (%)	4.2
N/A	Flare Type LT	N/A	N/A	Flare Type RT	N/A
N/A	Flare Slope LT (%)	N/A	N/A	Flare Slope RT (%)	N/A
N/A	Flare Traversable LT?	N/A	N/A	Flare Traversable RT?	N/A
N/A	Landing Length (in)	N/A	N/A	DWS Provided?	N/A
N/A	Landing Width (in)	N/A	N/A	DWS Contrast?	N/A
N/A	Landing Slope (%)	N/A	N/A	DWS Length (in)	N/A
N/A	Landing X Slope (%)	N/A	N/A	DWS Full Width?	N/A
N/A	Landing Curb? (Y/N)	N/A	N/A	DWS Offset (in)	N/A
N/A	Shared Landing?	N/A			
N/A	Gutter Ponding?	N/A	N/A	Gutter Slope (%)	N/A
N/A	Gutter Lip Ht (in)	N/A	N/A	Gutter X Slope (%)	N/A
N/A	Painted X Walk1?	No	N/A	Painted X Walk2?	No
	X Walk 1 Direction	To W		X Walk 2 Direction	To S
N/A	X Walk 1 Width (in)	N/A	N/A	X Walk 2 Width (in)	N/A
	X Walk 1 Slope (%)	1.7		X Walk 2 Slope (%)	0.9

X Walk 1 X Slope (%)	3.7		X Walk 2 X Slope (%)	2.2
N/A	Ramp inside XWalk1?	N/A	N/A	Ramp inside XWalk2?	N/A
	Road Slope (%)	4.0	N/A	Clear Space?	N/A
	Road X Slope (%)	1.9	N/A	Clear Space to XWalk (in)	N/A
N/A	Any Obstructions?	N/A	N/A	Storm Grate/Utility Hazard?	N/A

Remove & Replace Curb Ramp With Two New Directional Ramps or Equivalent.

Not Found, R304.2.2, R304.5.3
