Access Compliance Report Public Rights-of-Way (Curb Ramps)

Intersection ID: 8329Main Street:BEATTIES_FORD_RDCross Street:LASALLE_STLocation:SWADA ID: 310F1BB41D6DRamp Type:PerpInitial Pass/Fail:FailOverall Compliance:NoSeverity Score:10

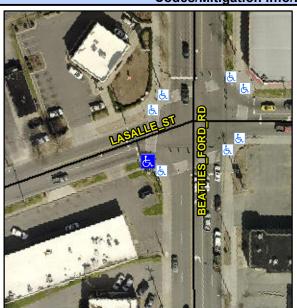
•	·	No	Ramp Width (in)	41.0	No	Ramp XSlope (%)	2.6	
		N/A	Flare Type LT	N/A	N/A	Flare Type RT	N/A	
		N/A	Flare Slope LT (%)	N/A	N/A	Flare Slope RT (%)	N/A	
		N/A	Flare Traversable LT?	N/A	N/A	Flare Traversable RT?	N/A	
		N/A	Landing Length (in)	N/A	N/A	DWS Provided?	N/A	
Surveyor Notes:		N/A	Landing Width (in)	N/A	N/A	DWS Contrast?	N/A	
N/A		N/A	Landing Slope (%)	N/A	N/A	DWS Length (in)	N/A	
		N/A	Landing X Slope (%)	N/A	N/A	DWS Full Width?	N/A	
		N/A	Landing Curb? (Y/N)	N/A	N/A	DWS Offset (in)	N/A	
		N/A	Shared Landing?	N/A				
PROW/ADA:		N/A	Gutter Ponding?	N/A	N/A	Gutter Slope (%)	N/A	
Not Found, R304.5.1, R304.5.3	5.1, R304.5.3	N/A	Gutter Lip Ht (in)	N/A	N/A	Gutter X Slope (%)	N/A	
·		N/A	Painted X Walk1?	Yes	N/A	Painted X Walk2?	N/A	
			X Walk 1 Direction	To N		X Walk 2 Direction	N/A	
		N/A	X Walk 1 Width (in)	120.5	N/A	X Walk 2 Width (in)	N/A	
			X Walk 1 Slope (%)	4.2		X Walk 2 Slope (%)	N/A	
			X Walk 1 X Slope (%)	2.3		X Walk 2 X Slope (%)	N/A

Possible Solution		Field Measurements/Component Compliance						
Possible Solutions:		Compliance Description			Compliance Description		Data	
Remove & Replace	Entire Ramp.	N/A	Ramp Length (in)	89.0	Yes	Ramp Slope (%)	5.6
