# Access Compliance Report

## Public Rights-of-Way

Intersection ID: 52476	Main Street: WHITEHALL_EXECUTIVE_CENTER_DR	Cross Street: CERNY_DR	Location: NE
ADA ID: 310F913DD8F3	Ramp Type: Perp	Initial Pass/Fail: Fail	Overall Compliance: No
Severity Score: 12.5			
Codes/Mitigation Info/Possible Solution		Field Measurements/Component Compliance

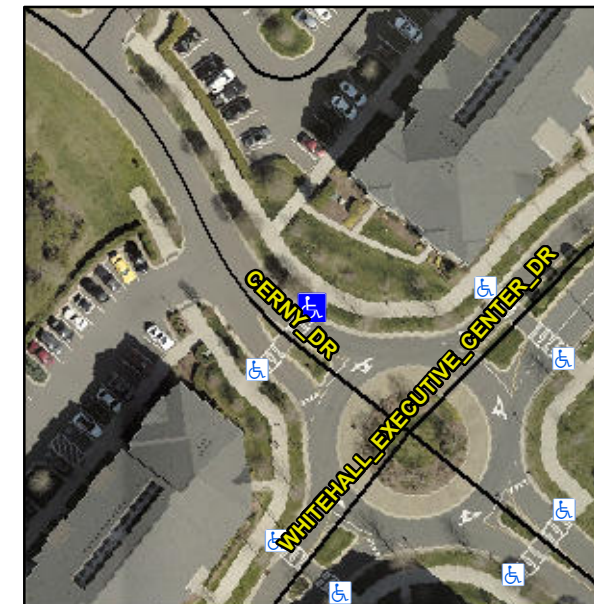
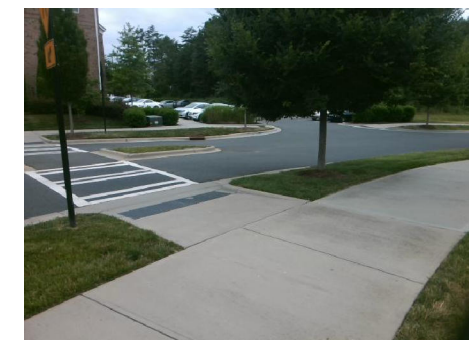
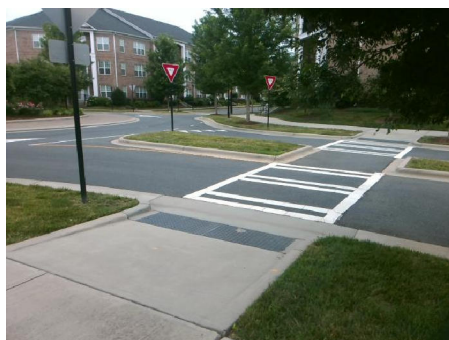
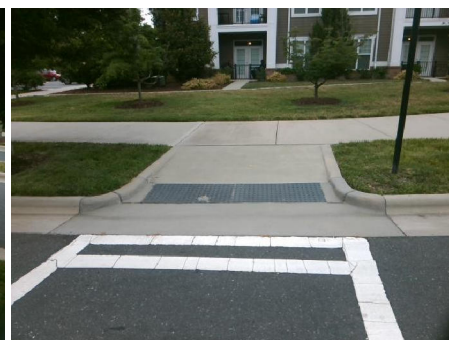
Compliance	Description	Data	Compliance	Description	Data
N/A	Ramp Length (in)	93.0	No	Ramp Slope (%)	8.8
Yes	Ramp Width (in)	89.0	Yes	Ramp XSlope (%)	1.4
N/A	Flare Type LT	N/A	N/A	Flare Type RT	N/A
N/A	Flare Slope LT (%)	N/A	N/A	Flare Slope RT (%)	N/A
N/A	Flare Traversable LT?	N/A	N/A	Flare Traversable RT?	N/A
N/A	Landing Length (in)	N/A	N/A	DWS Provided?	N/A
N/A	Landing Width (in)	N/A	N/A	DWS Contrast?	N/A
N/A	Landing Slope (%)	N/A	N/A	DWS Length (in)	N/A
N/A	Landing X Slope (%)	N/A	N/A	DWS Full Width?	N/A
N/A	Landing Curb? (Y/N)	N/A	N/A	DWS Offset (in)	N/A
N/A	Shared Landing?	N/A			
N/A	Gutter Ponding?	N/A	N/A	Gutter Slope (%)	N/A
N/A	Gutter Lip Ht (in)	N/A	N/A	Gutter X Slope (%)	N/A
N/A	Painted X Walk1?	Yes	N/A	Painted X Walk2?	N/A
	X Walk 1 Direction	To SW		X Walk 2 Direction	N/A
N/A	X Walk 1 Width (in)	94.0	N/A	X Walk 2 Width (in)	N/A
	X Walk 1 Slope (%)	4.3		X Walk 2 Slope (%)	N/A
	X Walk 1 X Slope (%)	0.2		X Walk 2 X Slope (%)	N/A

N/A	Ramp inside XWalk1?	Yes	N/A	Ramp inside XWalk2?	N/A
	Road Slope (%)	N/A	N/A	Clear Space?	N/A
	Road X Slope (%)	N/A	N/A	Clear Space to XWalk (in)	N/A
N/A	Any Obstructions?	N/A	N/A	Storm Grate/Utility Hazard?	N/A
	Obstruction Type			Storm Grate/Utility Type	
		N/A			N/A
		Yes		Surface Condition? (G/P)	Good

**Remove & Replace Entire Ramp.**

**R304.2.2**

**\$ 1850.00**
