Access Compliance Report Public Rights-of-Way (Curb Ramps)

Intersection ID: 24623 Main Street: CARMEL RD **Cross Street: WINDWOOD CR** Location: N ADA ID: 3116610D2E3C Ramp Type: PerpDiag Initial Pass/Fail: Fail **Overall Compliance: No Severity Score:** 12.5

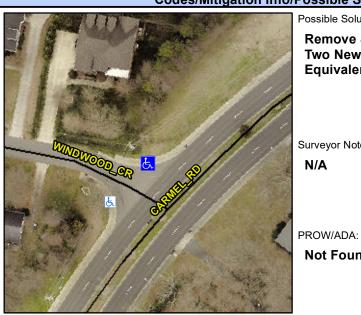
Not Found, R304.2.2

Compliance Description Date		Data	Comp	liance	Description	Data
N/A	Ramp Length (in)	59.0	No	Ramp	Slope (%)	9.7
Yes	Ramp Width (in)	53.0	Yes	Ramp	XSlope (%)	1.3
N/A	Flare Type LT	N/A	N/A	Flare	Type RT	N/A
N/A	Flare Slope LT (%)	N/A	N/A	Flare	Slope RT (%)	N/A
N/A	Flare Traversable LT?	N/A	N/A	Flare	Traversable RT?	N/A
N/A	Landing Length (in)	N/A	N/A	DWS	Provided?	N/A
N/A	Landing Width (in)	N/A	N/A	DWS	Contrast?	N/A
N/A	Landing Slope (%)	N/A	N/A	DWS	Length (in)	N/A
N/A	Landing X Slope (%)	N/A	N/A	DWS	Full Width?	N/A
N/A	Landing Curb? (Y/N)	N/A	N/A	DWS	Offset (in)	N/A
N/A	Shared Landing?	N/A				
N/A	Gutter Ponding?	N/A	N/A	Gutte	r Slope (%)	N/A
N/A	Gutter Lip Ht (in)	N/A	N/A	Gutte	r X Slope (%)	N/A
N/A	Painted X Walk1?	No	N/A	Painte	ed X Walk2?	No
	X Walk 1 Direction	To SW		X Wa	lk 2 Direction	To SE
N/A	X Walk 1 Width (in)	N/A	N/A	X Wa	lk 2 Width (in)	N/A
	X Walk 1 Slope (%)	0.8		X Wa	lk 2 Slope (%)	4.7
	X Walk 1 X Slope (%)	1.7		X Wa	lk 2 X Slope (%)	1.2

N/A	Ramp inside XWalk1?	N/A	N/A	Ramp	inside XWalk2?	N/A
	Road Slope (%)	1.7	N/A	Clear	Space?	N/A
	Road X Slope (%)	1.9	N/A	Clear	Space to XWalk (in)	N/A
N/A	Any Obstructions?	N/A	N/A	Storm	Grate/Utility Hazard?	N/A
	Obstruction Type		l	Storm	Grate/Utility Type	
		N/A				N/A

Possible Solutions: **Remove & Replace Curb Ramp With Two New Directional Ramps or** Equivalent. Surveyor Notes:

Total Cost: 3200.00
