Access Compliance Report

Public Rights-of-Way

(Curb Ramps)

Intersection ID: 2750	Main Street: BRADWELL_DR	Cross Street: MANTARIO_DR	Location:	N
ADA ID: 311B237C3B48	Ramp Type: PerpDiag	Initial Pass/Fail: Fail	Overall Compliance: No	Severity Score: 22.5
Codes/Mitigation Info/Possible Solution		Field Measurements/Component Compliance

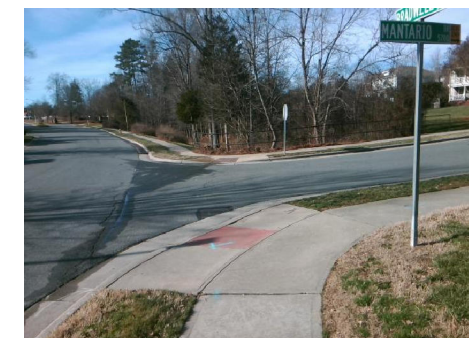
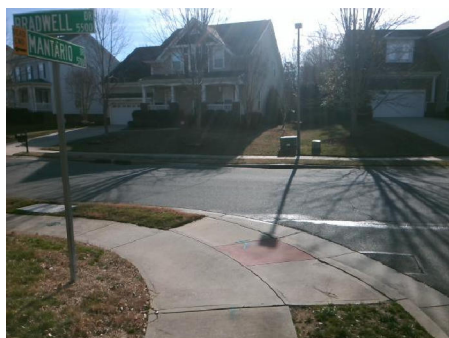
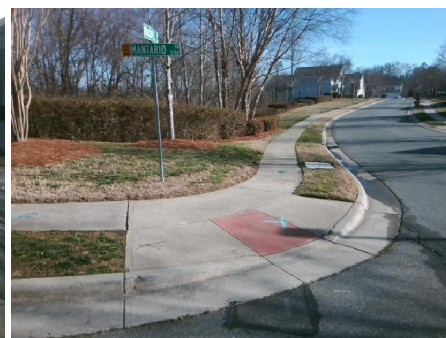
Compliance	Description	Data	Compliance	Description	Data
N/A	Ramp Length (in)	52.0	No	Ramp Slope (%)	10.4
No	Ramp Width (in)	36.0	No	Ramp XSlope (%)	2.4
N/A	Flare Type LT	N/A	N/A	Flare Type RT	N/A
N/A	Flare Slope LT (%)	N/A	N/A	Flare Slope RT (%)	N/A
N/A	Flare Traversable LT?	N/A	N/A	Flare Traversable RT?	N/A
N/A	Landing Length (in)	N/A	N/A	DWS Provided?	N/A
N/A	Landing Width (in)	N/A	N/A	DWS Contrast?	N/A
N/A	Landing Slope (%)	N/A	N/A	DWS Length (in)	N/A
N/A	Landing X Slope (%)	N/A	N/A	DWS Full Width?	N/A
N/A	Landing Curb? (Y/N)	N/A	N/A	DWS Offset (in)	N/A
N/A	Shared Landing?	N/A			
N/A	Gutter Ponding?	N/A	N/A	Gutter Slope (%)	N/A
N/A	Gutter Lip Ht (in)	N/A	N/A	Gutter X Slope (%)	N/A
N/A	Painted X Walk1?	No	N/A	Painted X Walk2?	No
	X Walk 1 Direction	To SW		X Walk 2 Direction	To SE
N/A	X Walk 1 Width (in)	N/A	N/A	X Walk 2 Width (in)	N/A
	X Walk 1 Slope (%)	1.5		X Walk 2 Slope (%)	0.9
	X Walk 1 X Slope (%)	2.0		X Walk 2 X Slope (%)	2.4

N/A	Ramp inside XWalk1?	N/A	N/A	Ramp inside XWalk2?	N/A
	Road Slope (%)	2.1	N/A	Clear Space?	N/A
	Road X Slope (%)	0.8	N/A	Clear Space to XWalk (in)	N/A
N/A	Any Obstructions?	N/A	N/A	Storm Grate/Utility Hazard?	N/A
	Obstruction Type			Storm Grate/Utility Type	
		N/A			N/A
			Yes	Surface Condition? (G/P)	Good

Remove & Replace Curb Ramp With Two New Directional Ramps or Equivalent.

R304.5.1, R304.2.2, R304.5.3
