Access Compliance Report

Public Rights-of-Way

(Curb Ramps)

Intersection ID: 2847	Main Street: BITTERBUSH_CT	Cross Street: WATERELM_LN	Location:	N
ADA ID: 311B9CBAE28D	Ramp Type: Perp	Initial Pass/Fail: Fail	Overall Compliance: No	Severity Score: 60
Codes/Mitigation Info/Possible Solution		Field Measurements/Component Compliance

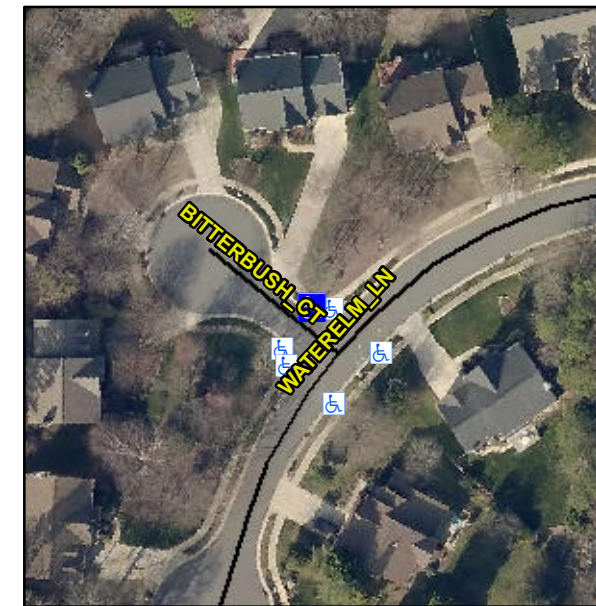
Not Found, R304.5.1, R304.2.2, R304.5.3

Compliance	Description	Data	Compliance	Description	Data
N/A	Ramp Length (in)	47.0	No	Ramp Slope (%)	10.0
No	Ramp Width (in)	26.0	No	Ramp XSlope (%)	6.3
N/A	Flare Type LT	N/A	N/A	Flare Type RT	N/A
N/A	Flare Slope LT (%)	N/A	N/A	Flare Slope RT (%)	N/A
N/A	Flare Traversable LT?	N/A	N/A	Flare Traversable RT?	N/A
N/A	Landing Length (in)	N/A	N/A	DWS Provided?	N/A
N/A	Landing Width (in)	N/A	N/A	DWS Contrast?	N/A
N/A	Landing Slope (%)	N/A	N/A	DWS Length (in)	N/A
N/A	Landing X Slope (%)	N/A	N/A	DWS Full Width?	N/A
N/A	Landing Curb? (Y/N)	N/A	N/A	DWS Offset (in)	N/A
N/A	Shared Landing?	N/A			
N/A	Gutter Ponding?	N/A	N/A	Gutter Slope (%)	N/A
N/A	Gutter Lip Ht (in)	N/A	N/A	Gutter X Slope (%)	N/A
N/A	Painted X Walk1?	No	N/A	Painted X Walk2?	N/A
	X Walk 1 Direction	To SW		X Walk 2 Direction	N/A
N/A	X Walk 1 Width (in)	N/A	N/A	X Walk 2 Width (in)	N/A
	X Walk 1 Slope (%)	5.5		X Walk 2 Slope (%)	N/A
	X Walk 1 X Slope (%)	7.2		X Walk 2 X Slope (%)	N/A

N/A	Ramp inside XWalk1?	N/A	N/A	Ramp inside XWalk2?	N/A
	Road Slope (%)	N/A	N/A	Clear Space?	N/A
	Road X Slope (%)	N/A	N/A	Clear Space to XWalk (in)	N/A
N/A	Any Obstructions?	N/A	N/A	Storm Grate/Utility Hazard?	N/A
	Obstruction Type			Storm Grate/Utility Type	
		N/A			N/A
			Yes	Surface Condition? (G/P)	Good

Possible Solutions:

Remove & Replace Entire Ramp.
