Intersection ID: 20863	Main Street: COVEDALE_DR	Cross Street: RIVERWOOD_RD	Location:	SW
ADA ID: 3137BAA7BA06	Ramp Type: PerpDiag	Initial Pass/Fail: Fail	Overall Compliance: No	Severity Score: 26.25

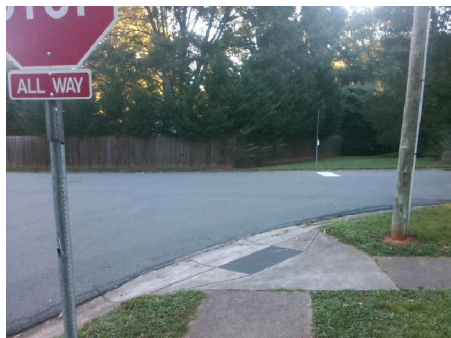
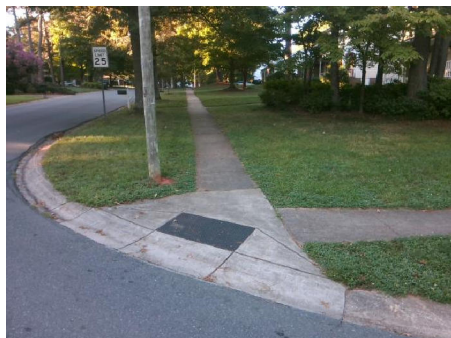
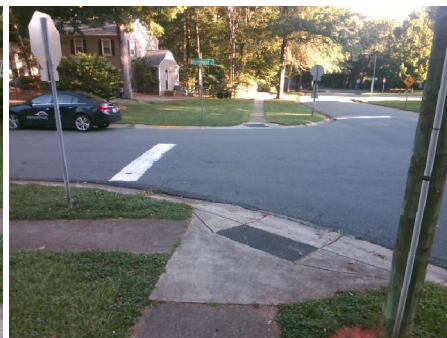
Possible Solutions:		Compliance	Description	Data	Compliance	Description	Data
	Remove & Replace Curb Ramp With Two New Directional Ramps or Equivalent.		N/A	Ramp Length (in)	25.0	No	Ramp Slope (%)	15.0
			Yes	Ramp Width (in)	48.0	No	Ramp XSlope (%)	3.5
			N/A	Flare Type LT	N/A	N/A	Flare Type RT	N/A
			N/A	Flare Slope LT (%)	N/A	N/A	Flare Slope RT (%)	N/A
			N/A	Flare Traversable LT?	N/A	N/A	Flare Traversable RT?	N/A
			N/A	Landing Length (in)	N/A	N/A	DWS Provided?	N/A
			N/A	Landing Width (in)	N/A	N/A	DWS Contrast?	N/A
			N/A	Landing Slope (%)	N/A	N/A	DWS Length (in)	N/A
			N/A	Landing X Slope (%)	N/A	N/A	DWS Full Width?	N/A
Surveyor Notes:	N/A		N/A	Landing Curb? (Y/N)	N/A	N/A	DWS Offset (in)	N/A
			N/A	Shared Landing?	N/A			
			N/A	Gutter Ponding?	N/A	N/A	Gutter Slope (%)	N/A
			N/A	Gutter Lip Ht (in)	N/A	N/A	Gutter X Slope (%)	N/A

N/A	Painted X Walk1?	No	N/A	Painted X Walk2?	No
				X Walk 1 Direction	To E		X Walk 2 Direction	To N
			N/A	X Walk 1 Width (in)	N/A	N/A	X Walk 2 Width (in)	N/A
				X Walk 1 Slope (%)	4.9		X Walk 2 Slope (%)	1.7
				X Walk 1 X Slope (%)	2.5		X Walk 2 X Slope (%)	4.2
			N/A	Ramp inside XWalk1?	N/A	N/A	Ramp inside XWalk2?	N/A
PROW/ADA:	Not Found, R304.2.2, R304.5.3			Road Slope (%)	6.2	N/A	Clear Space?	N/A
				Road X Slope (%)	5.6	N/A	Clear Space to XWalk (in)	N/A
			N/A	Any Obstructions?	N/A	N/A	Storm Grate/Utility Hazard?	N/A
				Obstruction Type			Storm Grate/Utility Type	
					N/A			N/A
						Yes	Surface Condition? (G/P)	Good
	Total Cost:		\$	3200.00
