| Intersection ID: 23225 | Main Street: CARMEL_RD | Cross Street: HILLINGDON_RD | Location: | W |
| ADA ID: 313CB45896EA | Ramp Type: PerpDiag | Initial Pass/Fail: Fail | Overall Compliance: No | Severity Score: 21.25 |

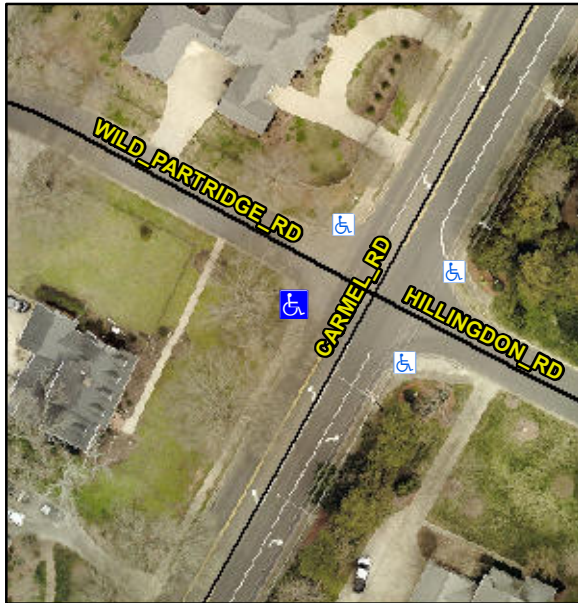
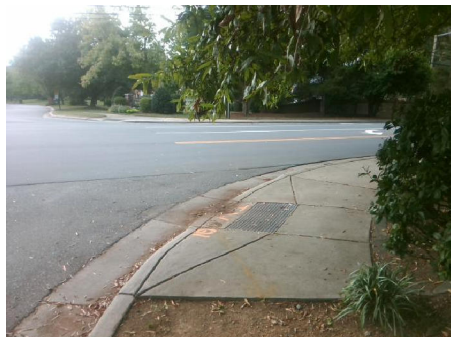
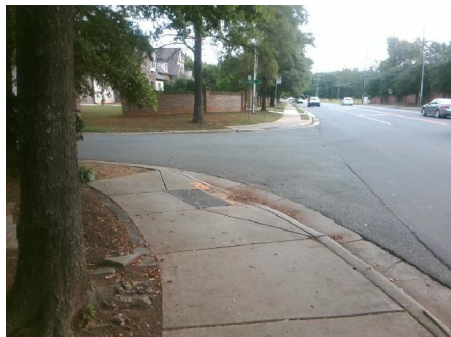
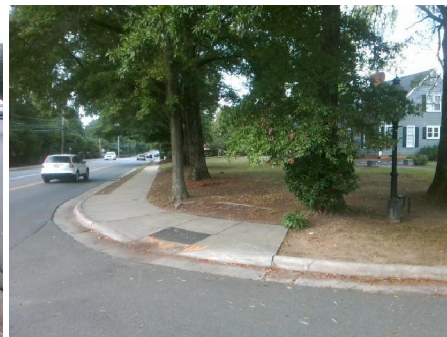
**Not Found, R304.5.1, R304.2.2**

| Compliance | Description | Data | Compliance | Description | Data |
|---|---|---|---|---|---|
| N/A | Ramp Length (in) | 77.0 | No | Ramp Slope (%) | 10.3 |
| No | Ramp Width (in) | 45.0 | Yes | Ramp XSlope (%) | 1.7 |

**Remove & Replace Curb Ramp With Two New Directional Ramps or Equivalent.**
