# Access Compliance Report

## Public Rights-of-Way

### (Curb Ramps)

Intersection ID: N/A	Main Street: IDLEWILD_RD	Cross Street: E_INDEPENDENCE_RA	Location: SE
ADA ID: 313D03FE1E23	Ramp Type: Perp	Initial Pass/Fail: Pass	Overall Compliance: No
			Severity Score: 10.25

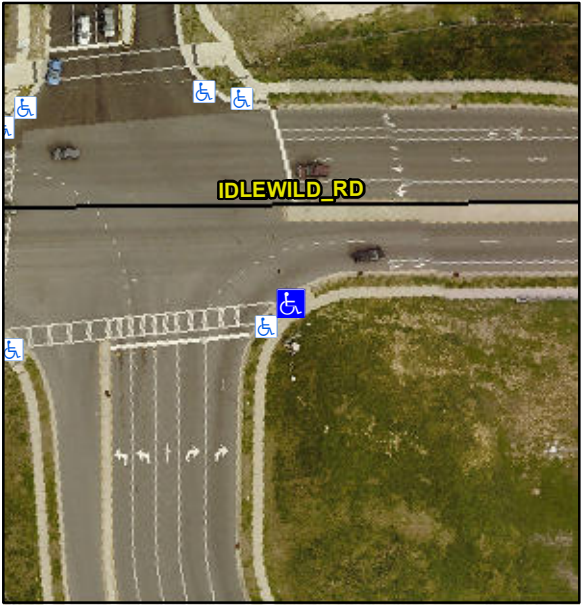
Possible Solutions:		<b>Compliance</b>	<b>Description</b>	<b>Data</b>
	Remove & Replace Entire Ramp.		N/A	Ramp Length (in)	65.0
	Remove & Replace Gutter.		Yes	Ramp Width (in)	59.5
			N/A	Flare Type LT	Sloped
			N/A	Flare Slope LT (%)	13.4
			N/A	Flare Traversable LT?	Yes
			Yes	Landing Length (in)	69.0
			Yes	Landing Width (in)	61.0
			Yes	Landing Slope (%)	0.7
			Yes	Landing X Slope (%)	2.3
<p>Surveyor Notes:</p> <p>N/A</p> <p>PROW/ADA:</p> <p>Not Found, R304.2.3, R304.5.4, R304.5.3</p>			N/A	Flare Type RT	N/A
			Yes	Flare Slope RT (%)	5.6
			N/A	Flare Traversable RT?	Yes
			Yes	DWS Provided?	Yes
			Yes	DWS Contrast?	Yes
			Yes	DWS Length (in)	24.0
			Yes	DWS Full Width?	Yes
			N/A	DWS Offset (in)	0.0
			N/A	Gutter Slope (%)	5.2
			N/A	Gutter X Slope (%)	8.9
<p>Total Cost:</p> <p>\$ 2600.00</p>			No	Painted X Walk1?	N/A
			No	Painted X Walk2?	N/A

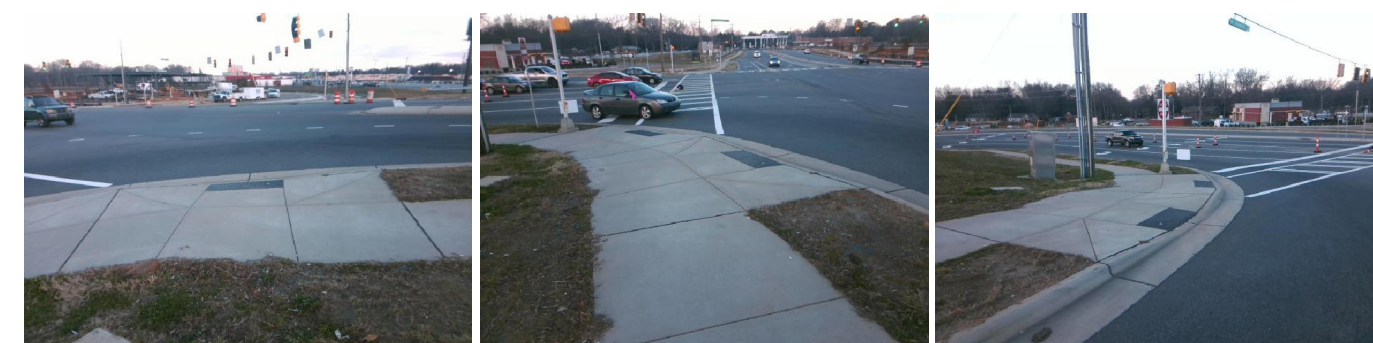
To N	X Walk 1 Direction	N/A
			N/A	X Walk 2 Direction	N/A
			N/A	X Walk 1 Width (in)	N/A
			N/A	X Walk 2 Width (in)	N/A
			7.3	X Walk 1 Slope (%)	N/A
			8.2	X Walk 2 Slope (%)	N/A
			N/A	X Walk 1 X Slope (%)	N/A
			N/A	X Walk 2 X Slope (%)	N/A
<p>Street 1 Name</p> <p>IDLEWILD RD</p> <p>Stop Condition-Street 2</p> <p>Signal</p> <p>Street 2 Name</p> <p>N/A</p> <p>Stop Condition-Street 1</p> <p>N/A</p>			N/A	Ramp inside XWalk1?	N/A
			N/A	Ramp inside XWalk2?	N/A
			N/A	Road Slope (%)	Yes
			N/A	Road X Slope (%)	N/A
			Yes	Clear Space?	Yes
			No	Clear Space to XWalk (in)	N/A
			Yes	Storm Grate/Utility Hazard?	No
				Storm Grate/Utility Type	
			N/A		N/A
			Yes	Surface Condition? (G/P)	Good
