# Access Compliance Report

## Public Rights-of-Way

### (Curb Ramps)

| ADA ID: 314889960B53 | Ramp Type: Perp | Initial Pass/Fail: Pass | Overall Compliance: No |

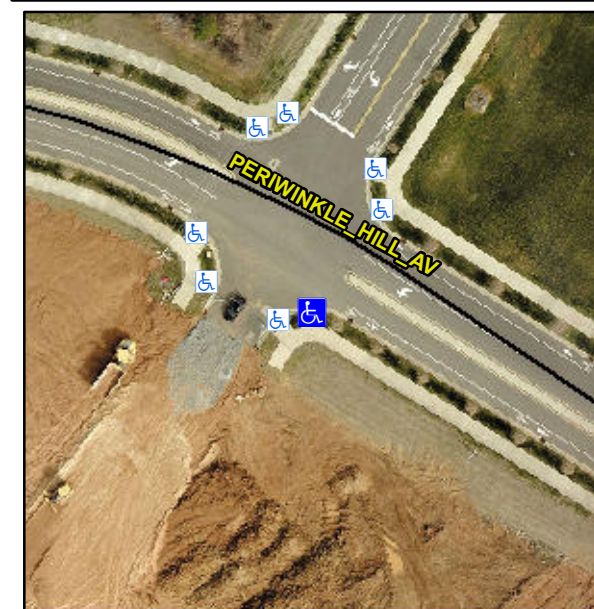
**R305.2, R304.5.3**

| Compliance | Description | Data | Compliance | Description | Data |
|---|---|---|---|---|---|
| N/A | Landing Curb? (Y/N) | No | No | DWS Offset (in) | 4.5 |
| Yes | Gutter Lip Ht (in) | 0.0 | No | Gutter X Slope (%) | 3.1 |

**Remove & Replace Detectable Warning System. Remove & Replace Gutter.**
