## Access Compliance Report Public Rights-of-Way (Curb Ramps)

Intersection ID: 50651Main Street:PINE\_GLEN\_CTCross Street:PINE\_TERRACE\_CTLocation:WADA ID: 314F7666A9A1Ramp Type:PerpDiagInitial Pass/Fail:FailOverall Compliance:NoSeverity Score:22.5

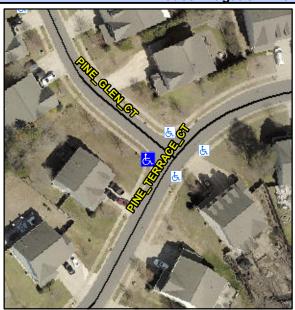
Field Measure	ments/C	ompo	nent Compliance		
Comp	Compliance Description		Comp	liance Description	Data	
N/A	Ramp Length (in)	48.5	No	Ramp Slope (%)	8.6	
No	Ramp Width (in)	46.5	No	Ramp XSlope (%)	2.5	
N/A	Flare Type LT	N/A	N/A	Flare Type RT	N/A	
N/A	Flare Slope LT (%)	N/A	N/A	Flare Slope RT (%)	N/A	
N/A	Flare Traversable LT?	N/A	N/A	Flare Traversable RT?	N/A	
N/A	Landing Length (in)	N/A	N/A	DWS Provided?	N/A	
N/A	Landing Width (in)	N/A	N/A	DWS Contrast?	N/A	
N/A	Landing Slope (%)	N/A	N/A	DWS Length (in)	N/A	
N/A	Landing X Slope (%)	N/A	N/A	DWS Full Width?	N/A	
N/A	Landing Curb? (Y/N)	N/A	N/A	DWS Offset (in)	N/A	
N/A	Shared Landing?	N/A				
N/A	Gutter Ponding?	N/A	N/A	Gutter Slope (%)	N/A	
N/A	Gutter Lip Ht (in)	N/A	N/A	Gutter X Slope (%)	N/A	
N/A	Painted X Walk1?	No	N/A	Painted X Walk2?	No	
	X Walk 1 Direction	To SE		X Walk 2 Direction	To NE	
N/A	X Walk 1 Width (in)	N/A	N/A	X Walk 2 Width (in)	N/A	
	X Walk 1 Slope (%)	2.0		X Walk 2 Slope (%)	4.4

X Walk 1 X Slope (%)	4.1		X Walk 2 X Slope (%)	2.4	
N/A	Ramp inside XWalk1?	N/A	N/A	Ramp inside XWalk2?	N/A	
	Road Slope (%)	3.3	N/A	Clear Space?	N/A	
	Road X Slope (%)	3.1	N/A	Clear Space to XWalk (in)	N/A	
N/A	Any Obstructions?	N/A	N/A	Storm Grate/Utility Hazard?	N/A	
	Obstruction Type			Storm Grate/Utility Type		
		N/A			N/A	
			Yes	Surface Condition? (G/P)	Good

Remove & Replace Curb Ramp With
Two New Directional Ramps or
Equivalent.

PROW/ADA:
R304.5.1, R304.2.2, R304.5.3
