Access Compliance Report

Public Rights-of-Way

(Curb Ramps)

Intersection ID: 43356	Main Street: PROSPERITY COMMONS DR	Cross Street: PROSPERITY VIEW DR	Location: S
ADA ID: 3155F3D8A7B8	Ramp Type: PerpDiag	Initial Pass/Fail: Fail	Overall Compliance: No
Codes/Mitigation Info/Possible Solution		Field Measurements/Component Compliance

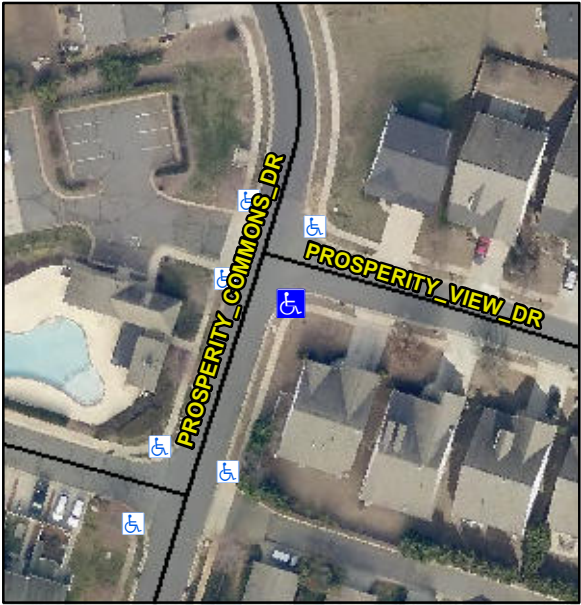
Possible Solutions:	Compliance	Description	Data	Compliance	Description	Data
	Remove & Replace Curb Ramp With Two New Directional Ramps or Equivalent.	N/A	Ramp Length (in)	48.0	No	Ramp Slope (%)	12.3
<p>Surveyor Notes:</p> <p>N/A</p> <p>PROW/ADA:</p> <p>Not Found, R304.5.1, R304.2.2</p>		No	Ramp Width (in)	41.0	Yes	Ramp XSlope (%)	1.6
		N/A	Flare Type LT	N/A	N/A	Flare Type RT	N/A
		N/A	Flare Slope LT (%)	N/A	N/A	Flare Slope RT (%)	N/A
		N/A	Flare Traversable LT?	N/A	N/A	Flare Traversable RT?	N/A
		N/A	Landing Length (in)	N/A	N/A	DWS Provided?	N/A
		N/A	Landing Width (in)	N/A	N/A	DWS Contrast?	N/A
		N/A	Landing Slope (%)	N/A	N/A	DWS Length (in)	N/A
		N/A	Landing X Slope (%)	N/A	N/A	DWS Full Width?	N/A
		N/A	Landing Curb? (Y/N)	N/A	N/A	DWS Offset (in)	N/A
		N/A	Shared Landing?	N/A			
		N/A	Gutter Ponding?	N/A	N/A	Gutter Slope (%)	N/A
		N/A	Gutter Lip Ht (in)	N/A	N/A	Gutter X Slope (%)	N/A
		N/A	Painted X Walk1?	No	N/A	Painted X Walk2?	No

X Walk 1 Direction	To NE		X Walk 2 Direction	To NW
		N/A	X Walk 1 Width (in)	N/A	N/A	X Walk 2 Width (in)	N/A
			X Walk 1 Slope (%)	2.2		X Walk 2 Slope (%)	0.4
			X Walk 1 X Slope (%)	0.8		X Walk 2 X Slope (%)	1.6
		N/A	Ramp inside XWalk1?	N/A	N/A	Ramp inside XWalk2?	N/A
			Road Slope (%)	0.5	N/A	Clear Space?	N/A
			Road X Slope (%)	3.5	N/A	Clear Space to XWalk (in)	N/A
		N/A	Any Obstructions?	N/A	N/A	Storm Grate/Utility Hazard?	N/A
			Obstruction Type			Storm Grate/Utility Type	
				N/A			N/A
					Yes	Surface Condition? (G/P)	Good
