Access Compliance Report Public Rights-of-Way (Curb Ramps)

Cross Street: W 24TH ST Intersection ID: 10135 Main Street: HOBBS ST Location: W Initial Pass/Fail: Fail **Overall Compliance: No** 22.5 ADA ID: 31629D7332E8 Ramp Type: Combination2 **Severity Score:**

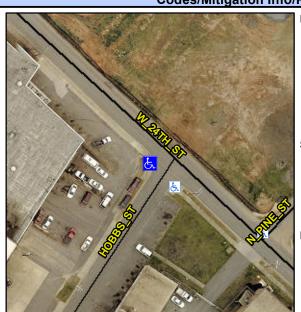
Possible Solutions: Compliance Description N/A Remove & Replace Entire Ramp. N/A N/A N/A N/A No Surveyor Notes: N/A LT RP < 5% N/A N/A N/A N/A PROW/ADA: N/A Not Found, R304.5.1, R304.2.2, N/A R304.5.3 N/A N/A N/A N/A N/A
